Source: *APT Bulletin: The Journal of Preservation Technology*, 2024, Vol. 54, No. 1/2, Special Issue: Graffiti (2024), pp. 33-40

Paint of Protest and Commemoration: A Berlin Wall Section at the United Nations

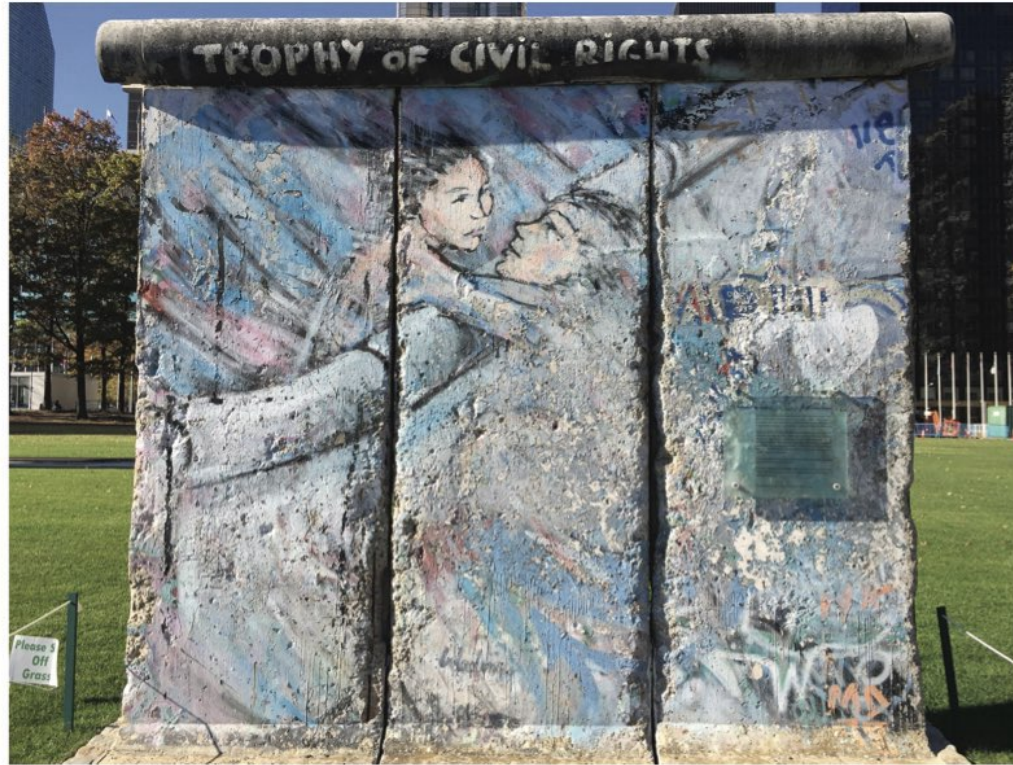
Fig. 1. Section of the Berlin Wall now located at the United Nations sculpture garden, 760 United Nations Plaza, Manhattan, New York. East side of the wall section before treatment, 2016. Unless noted otherwise, all images courtesy of EverGreene Architectural Arts.

In 2016 the authors were contracted to provide emergency stabilization of a painted section of the Berlin Wall at the United Nations sculpture garden in New York City. This section of the wall is historically significant for its association with the barrier that divided East Berlin and West Berlin during the Cold War. The east and west faces of the wall section present divergent themes. While the east face contains a commemorative mural painted by a professional artist that appears to cover pre-existing graffiti, the west face appears to be covered with multiple layers of graffiti that may have been applied over a period of approximately 15 years (and may have expressed protest or other political messaging), most of which is no longer visible. An intriguing aspect of the wall fragment is the extent to which the content, attribution, and significance represented by most of the paint layers is unknown; they represent a palimpsest of voices each speaking to their own times. The preservation of the more recent graffiti protects layers of potential historical data contained beneath the presenting surface (Fig. 1).

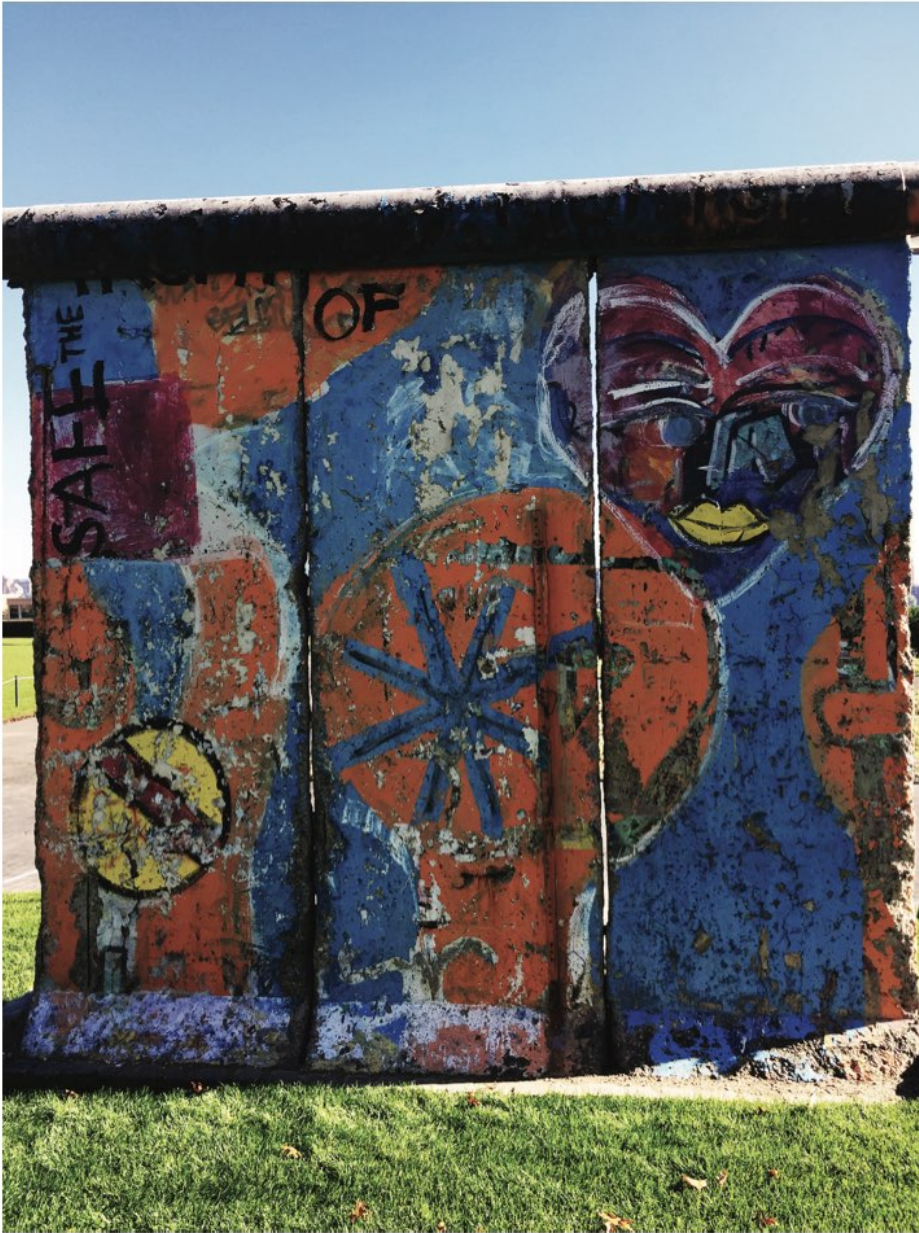
In 2002 a portion of the wall painted by Kani Alavi was donated to the United Nations sculpture garden in New York City. The wall section consists of three structurally distinct panels of steel-reinforced concrete, with each panel measuring approximately 4 feet wide by 12 feet high. The aggregate in the concrete varies widely, suggesting that it is ungraded, with the binder most likely being Portland cement. The panels were precast units with grooves in each end and with what appears to be mortar or concrete placed into the groove for additional stability. The three panels are capped with a three-quarter-round hollow cement cylinder, beneath which is exposed rebar set into a groove at the top of each section (Fig. 2).

Fig. 2. West side of the wall section before treatment, 2016.

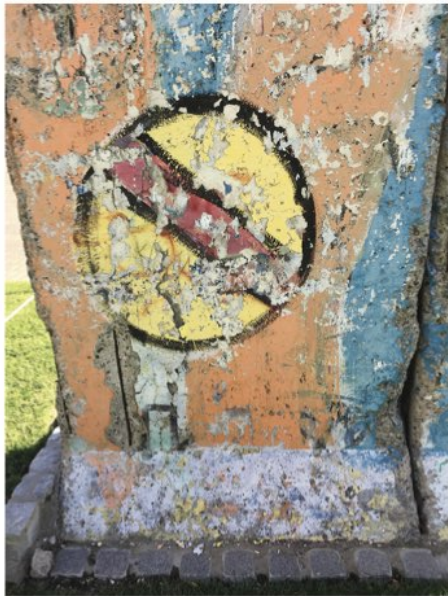
and the concrete substrate were both deteriorating. Changes to landscaping details carried out in the summer and fall of 2016 resulted in the removal of shrubbery that had provided shelter from winds coming off the nearby East River. In addition, site grading was altered, resulting in ponding and accumulation of water at the base of the wall, which expedited the deterioration

The paint that was used to create the artwork was most likely household paint, much of which may not have been manufactured for outdoor use and thus was not performing well in the exterior environment. Exposure to sunlight had caused the paint to become brittle and shrink over time, which was evident in the color fading and craquelure across the surface. Further paint delamination was characterized by tenting and peeling layers. There also appeared to be a lack of adhesion in between the graffiti campaigns where different types of paint were used and where dirt layers prevented proper paint adhesion. Chips of paint that had fallen off were collected along the bottom edge

Fig. 3. Paint that had detached and fallen to the ground before treatment, 2016.

Due to the expedited schedule required by the client, treatment testing was largely confined to evaluating paint solubility. The most expedient method of testing was to utilize paint samples that had detached and fallen from the mural onto the ground. Solvent testing was performed on each of the presenting paint colors for which samples were available. This testing was completed to ensure that the solvents used in the consolidants would not dissolve the paint. Acrylic and acrylic-latex paints are sensitive to many solvents, including alcohols, aromatic hydrocarbons, and ketones (like acetone). Samples were procured from the fallen paint chips at the base of the panels, with representative examples of each paint color submitted to solvent testing. Ethanol, mineral spirits, filtered water, and acetone were selected to test solubility, as those are the most common solvents used with paint consolidants. Solvent testing indicated that every color reacted to acetone, and all colors but the white paint exhibited sensitivity to ethanol (Fig. 5).

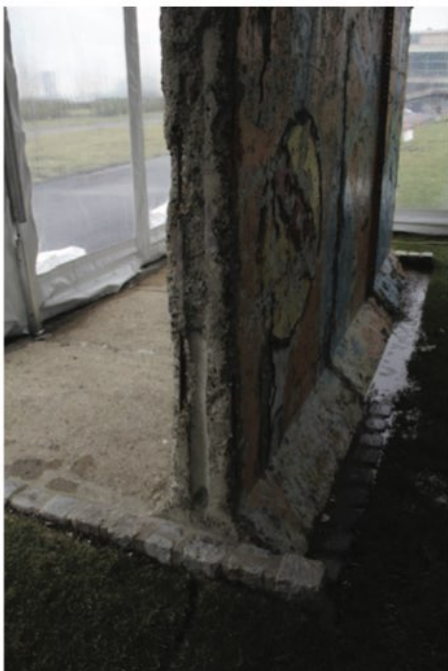
Fig. 4. Flooding at the foot of the wall section before treatment, one of the reasons for the substrate degradation and rapid paint loss, 2016.

The first portion of the treatment focused on the removal of deposits of biological growth such as algae, moss, and lichen that had formed along the base of the wall units, concentrating in the crease between the vertical sections and the horizontal base. Recurring flooding of the site contributed to increased deposits of biological growth and caused damage to the concrete wall and mural paint stemming from wet/dry and freeze/thaw cycling. The flooded area and concrete base were slowly dried out by directing a heated fan at the base. Daily moisture monitoring was completed using a pin moisture meter. Diluted D/2 Biological Solution was used to remove the biological growth.

Though EverGreene approached this project as emergency stabilization or triage due to the budget, environmental limitations, and scheduling constraints, a long-term, more measured approach would include monitoring, assessment, and possible re-configuration of the base or pad under the wall section. The project did not represent an in-depth, comprehensive treatment; nevertheless, the historic artifact was stabilized temporarily, slowing down the rate of deterioration and saving a significant portion of historic paint and imagery. The range of incompatible materials, such as acrylic and interior paints, will always pose a challenge to the longevity

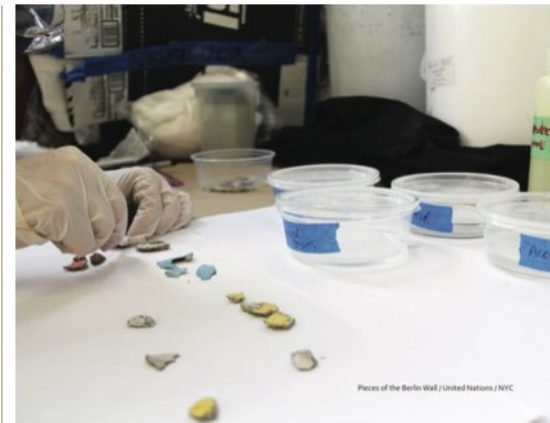
The solubility of the mural paint also affected the selection of potential paint re-adhesion treatments. For polymer adhesives to be stable in an outdoor environment, they must have a higher glass transition temperature (T_g), which represents the temperature at which the dried adhesive becomes soft or rubbery (as opposed to the glassy or crystalline state it has in cooler temperatures). Adhesives that have a higher T_g , such as synthetic resins Paraloid B48-N and B-72, require dissolution in more reactive solvents. The paints' sensitivity to those solvents limited the selection of adhesives. The best candidates were acrylic dispersion adhesives with thermoplastic characteristics, requiring

Fig. 5. Solvent testing of the various types of paint to determine the best adhesive, 2016.

Delaminated paint was re-adhered to the surface using both Plextol B500, which has a Tg of 9 degrees Celsius, and Lascaux 498 HV, with a Tg of 6 degrees Celsius. These acrylic dispersions were selected because they did not harm the paint media and could adhere the paint quickly with the use of a tacking iron. However, the low glass transition temperature was a concern for the application in an exterior environment because the adhesive could become tacky in localized areas of heat (particularly when the sun shines directly on the darker and metallic paints) and could shrink during freezing cycles. It was communicated to the client that the treatments would have limited longevity (requiring monitoring and re-treatment), and product information was submitted indicating that the selected materials were not intended for outdoor use.

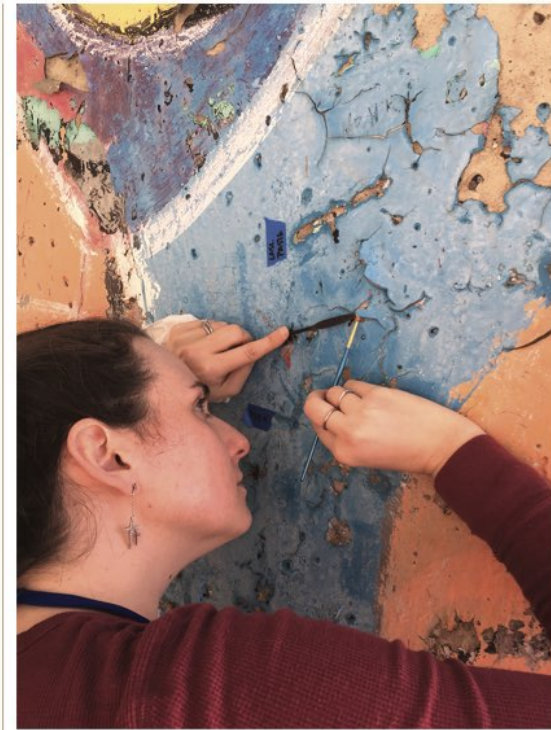
light pressure with a tacking iron or heated spatula to properly set paint flakes back into contact with the substrate. This presented challenges where the acrylic paint had become brittle from UV light damage. Some portions of the paint had delaminated and curled away from the substrate, creating a ribbon effect. These ribbons were extremely deformed and delicate.

Fig. 6. Paint readhesion on the west side of the wall section, 2017.

The reattachment of the brittle and curled ribbons of paint presented additional challenges. Once the adhesive was applied to the back of the ribbon (some ribbons had to be applied in small sections), heat was used to soften the deformed ribbons to make them sufficiently malleable to be reattached to the substrate. Pressing with a tacking iron was not feasible, as it would have put too much pressure on the paint, as well as any surrounding delamination, causing more damage and paint loss. A heat gun, used at its lowest setting, was used to soften the paint so that it could be reshaped and adhered. The heat gun was held approximately 12 to 15 inches from the area of delamination and waved slowly over the paint until it was malleable enough to be slowly and gently reshaped. The process had to be started and stopped to allow time for the paint to cool. Micro-spatulas with a silicon release paper were used to reset the paint; it was noted that Teflon-coated micro-spatulas left black marks on the surface (Fig. 6).

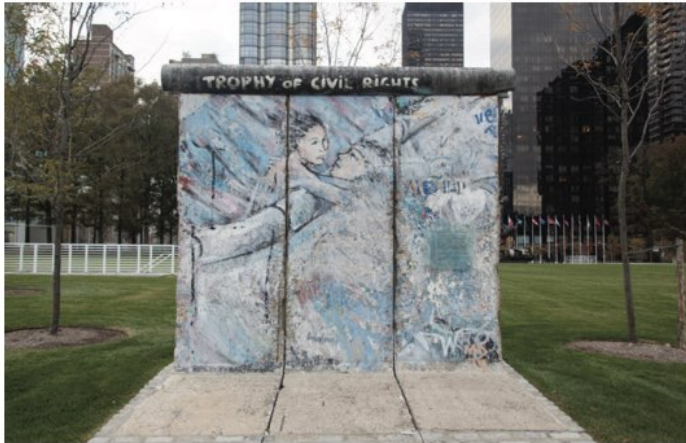
Fig. 7. East side of the wall section after treatment. Courtesy of Michelle Young, Untapped Cities, untappedcities.com.

Once the paint consolidation was complete, corrosion was removed from exposed rebar with a steel brush. A corrosion converter solution was applied by brush in two to three rounds to slow ongoing corrosion of the steel. The selected material was Rust-Oleum Rust Reformer 8 ounce liquid conversion treatment. Spalls were then filled with a pozzolanic hydraulic lime-based injection grout, set back

into plane as much as the expanded rebar would allow, and left to cure. The selected grout was Void Span 600 Series PHLC70, formulated for small areas of separation and dutchman adhesion (Figs. 7 and 8).

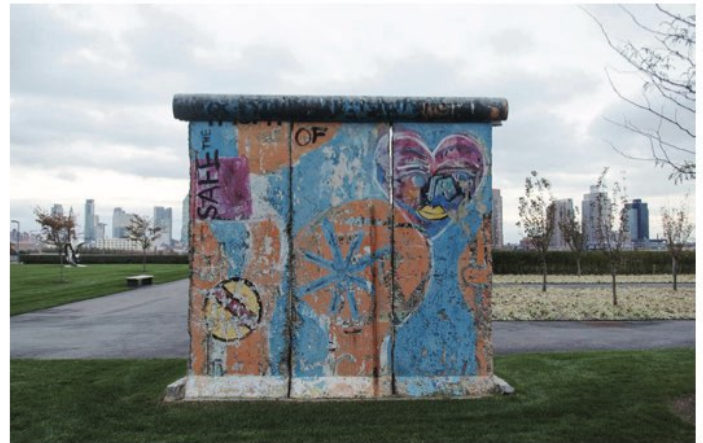
Fig. 8. West side of the wall section after treatment. Courtesy of Michelle Young, Untapped Cities, untappedcities.com.

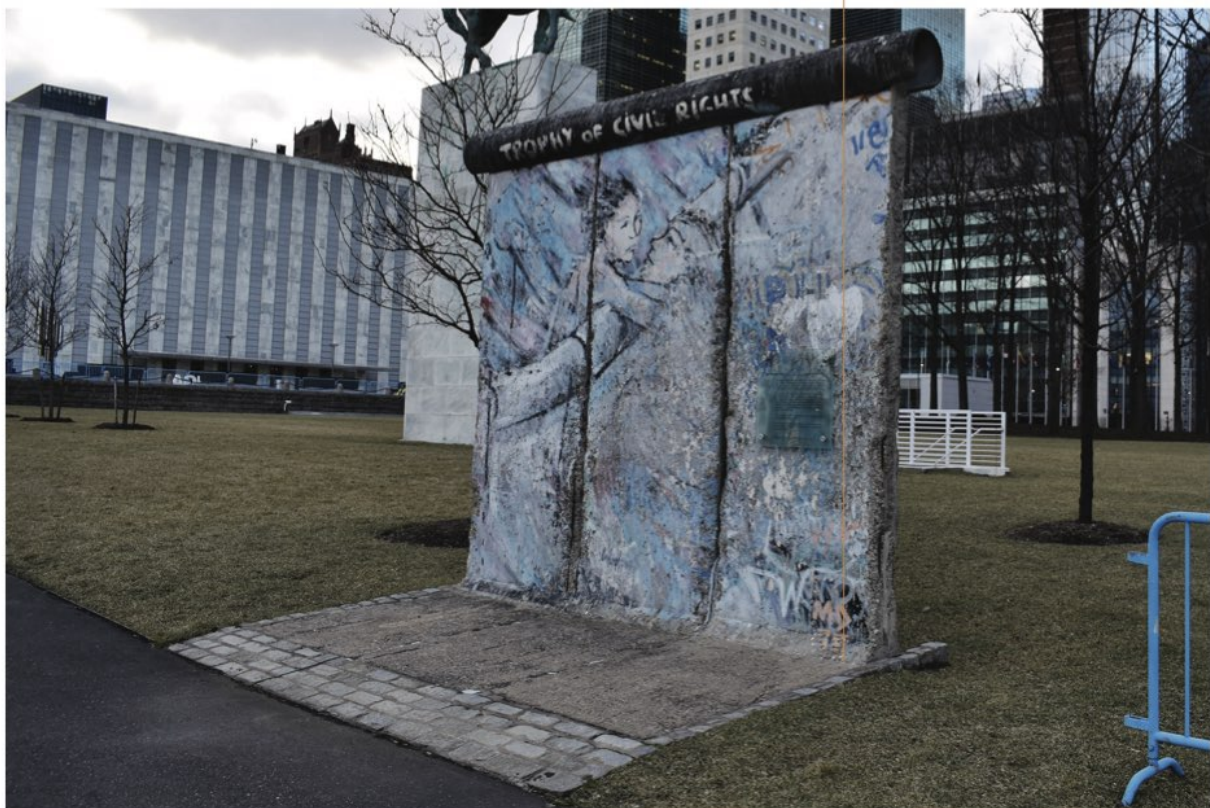
Fig. 9. East side of the wall section showing the continued efficacy of the treatments, 2023. Courtesy of Gillian Randell.

of the piece and will require continued monitoring and maintenance (Figs. 9 and 10).

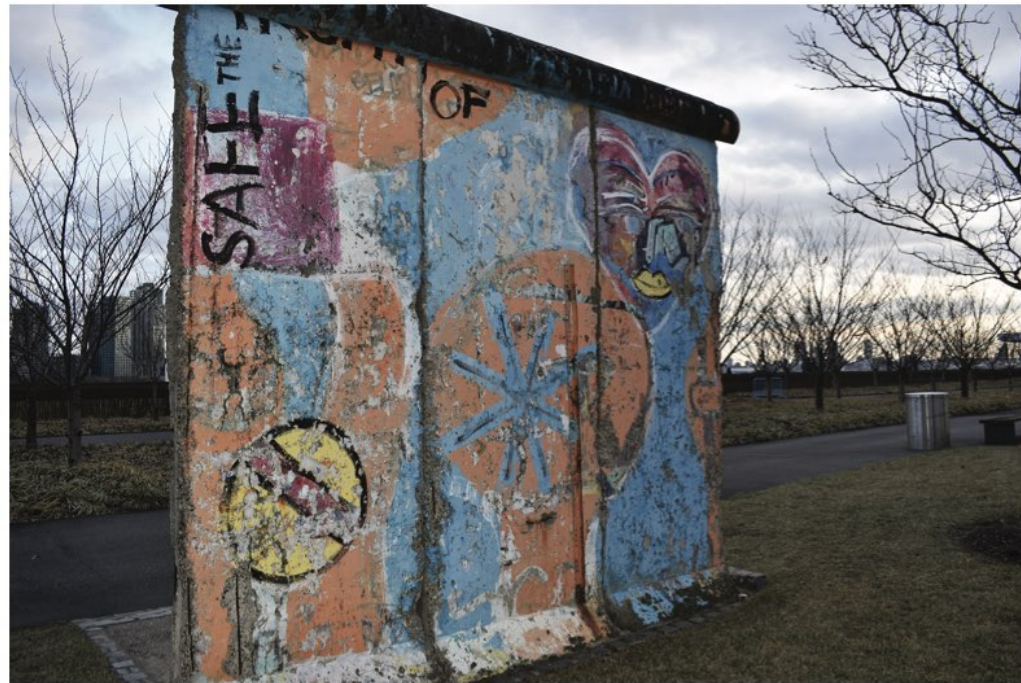
Fig. 10. West side of the wall section showing the continued efficacy of the treatments, 2023. Courtesy of Gillian Randell.
