Alabaster Sconces

FALLS CHURCH, VA

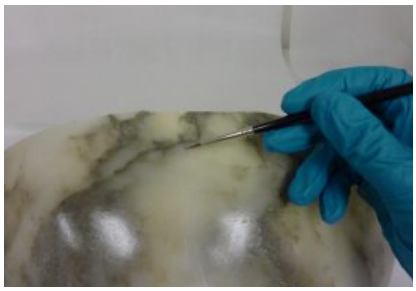
This sconce, one of a pair in the Art Deco style, had become damaged during shipping and we were asked to reconstruct the shade to enable it to be used for lighting. Each sconce has a half dome shade made from off-white alabaster veined with grey. Prior to conservation, one of the shades was cracked into two fragments of roughly equal size and there were some slight chips and small areas of loss along the crack.

Our conservators readhered the two broken pieces of the shade using a conservation adhesive, and filled small areas of loss along the edge of the crack. These fills were then color matched using acrylic paints. As lamp shades must withstand the heat and light from a bulb, materials and recommendations for use and care were carefully chosen to give the alabaster the required strength and aesthetic finish, but also enable the sconce to be lit.
