Iwo Jima Monument Assessment

MARINE CORPS DEPOT, PARRIS ISLAND, SC

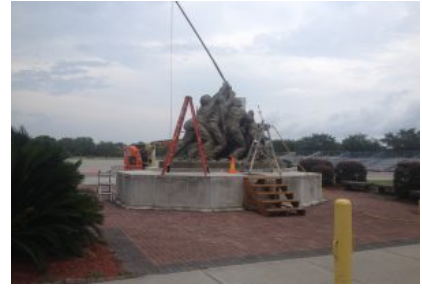
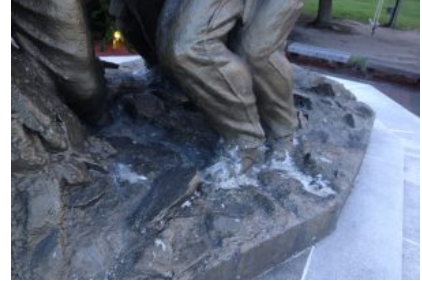
The monument is in poor condition due to a number of factors related to its material composition and construction methods. A previous conservation assessment established that the cast stone was deteriorating, and that the interior iron armature was likely in poor condition and contributing the failure of the cast stone. We were part of a team of conservators, engineers, and technicians that were contracted to perform an investigation of the armature and provide recommendations for treatment.

As a part of the investigation, a team of radiographers took x-rays of the entire monument. Conservators analyzed x-rays to map the network of iron reinforcement, and to locate areas of heavy corrosion and breaks in the iron. In efforts to document the entire sculpture's form, 3-D laser scanning was performed. These two technologies were used to gain a better understanding of the conditions and formulate a plan for conservation that would include the treatment of the armature and exterior shell in situ.
