The New York Public Library Statuary– Marble Deterioration & Conservation

Abstract

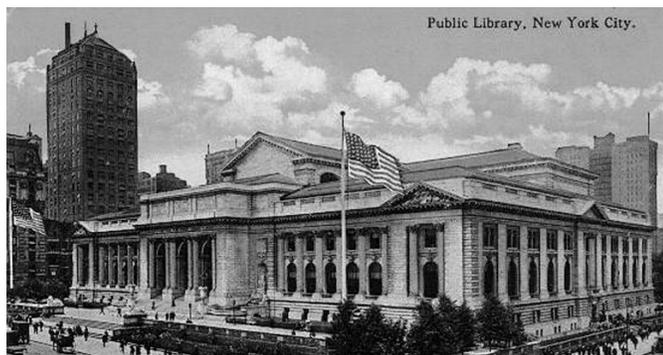
Figure1. Historic postcard showing statuary on NYPL 5th Ave. façade.

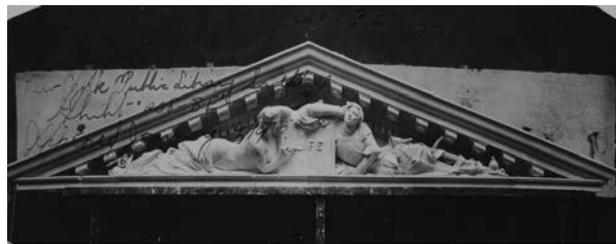
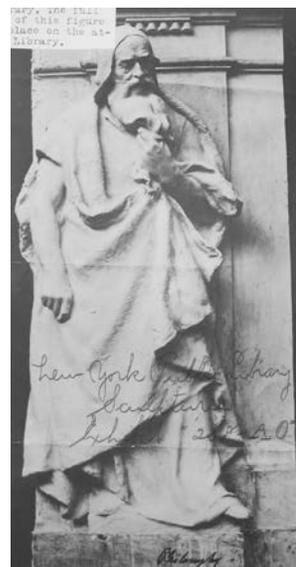
Figures 2,3: Half scale plaster mock-ups of proposed sculptures by Barnard (above) and Bartlett (right) from New York City Art Commission archives.
