Proceedings of
Preserving US Military Heritage: World War II to the Cold War
Fredericksburg, Texas, June 4-6, 2019

Conservation of the Iwo Jima Monument Parris Island for the United States Marine Corps

Claudia G. Chemello and Paul Mardikian, Terra Mare Conservation, LLC, Charleston, South Carolina; and Joseph Sembrat and Mark J. Rabinowitz, Evergreene Architectural Arts, Inc., District Heights, Maryland

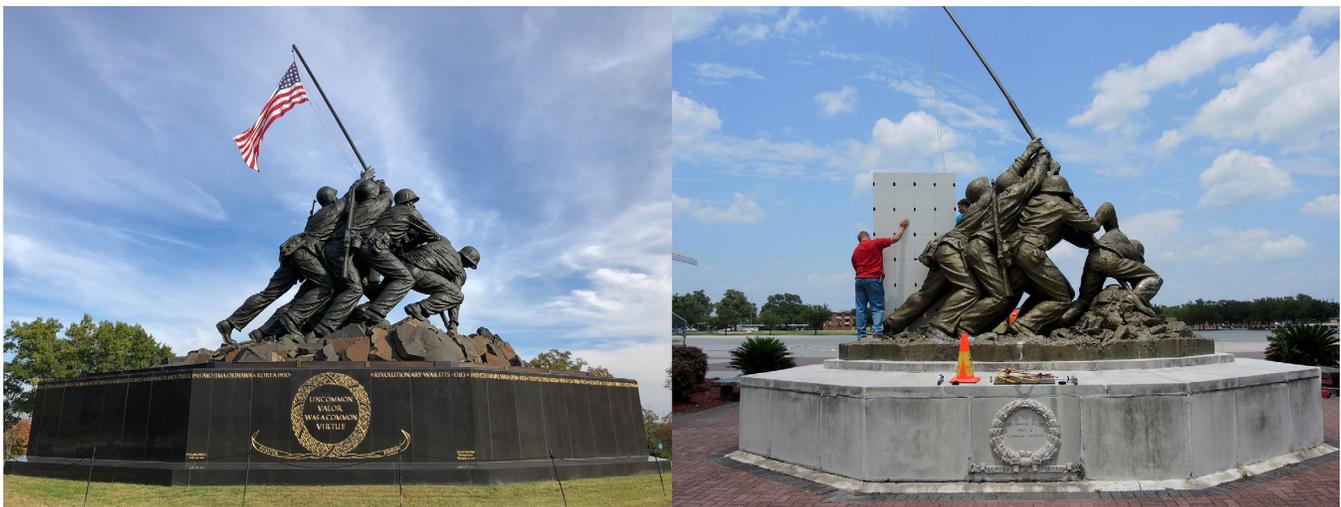
Figure 1. The Iwo Jima Memorial in Arlington (left, Famartin CC BY-SA 4.0, Creative Commons License) and the Iwo Jima Monument at the Marine Corps Recruit Depot Parris Island during the X-ray survey (right) https://en.wikipedia.org/wiki/Marine_Corps_War_Memorial

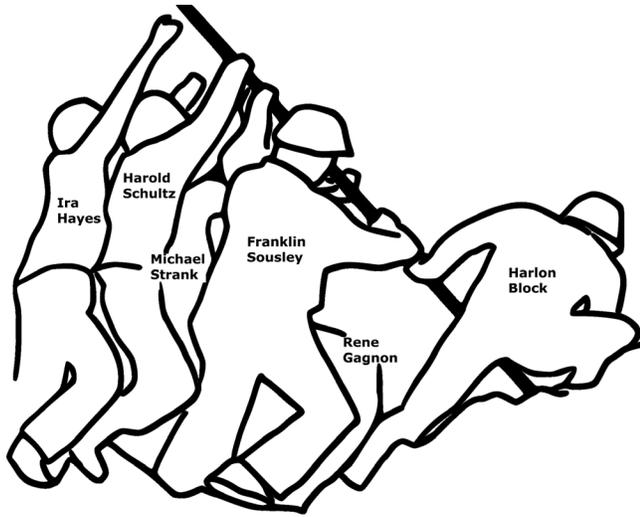
Based on the 2014 X-ray survey which identified areas of definite or probable rebar corrosion, 21 areas were identified as priorities for excavation. These areas were predominantly located on the lower legs of the figures (see Figure 4), where cracking and deterioration were widespread, as well as several areas on the upper back of Hayes, on the hands around the flagpole, and where the flagpole enters the body of Block.

Figure 4. A diagram of the photograph indicating the six Marines who raised the second flag. Left to right: Ira Hayes, Harold Schultz, Michael Strank (†), Franklin Sousley (†), Rene Gagnon, and Harlon Block (†). «†» = killed on Iwo Jima. Source: Aeoris (https://commons.wikimedia.org/wiki/File:Raising_the_Flag_outline.svg), "Raising the Flag outline", <https://creativecommons.org/licenses/by-sa/3.0/legalcode>

5). Registration marks were made on the sections that were removed so that they could be reattached in their exact locations at a later date. These processes were documented in field drawings and photographs. Once sections of the outer shell were removed and the internal clay exposed, these areas were excavated using pneumatic chisels and other hand tools, and/or pressurized water at 3,000 psi with rotating nozzles. In some areas such as the left foot of Hayes, a particularly problematic area, water and loose clay core flowed out of the cavity after removing the concrete shell as excess moisture was retained inside the cavity. The clay core in this area was completely saturated.
