Franklin County Courthouse

HAMPTON, IA

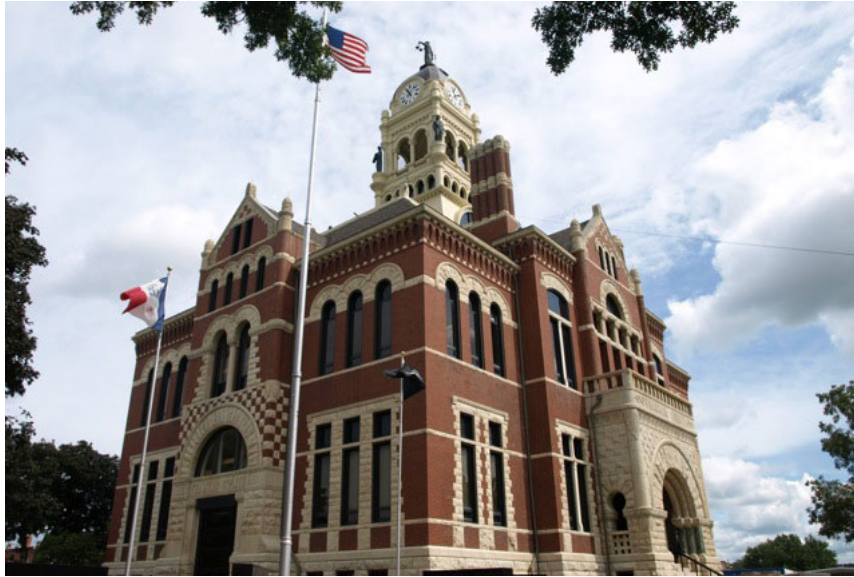
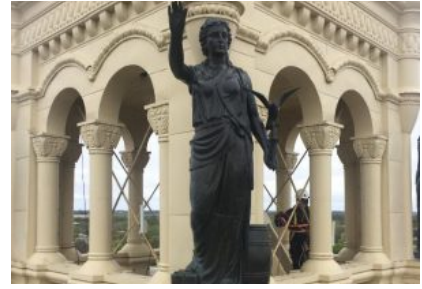
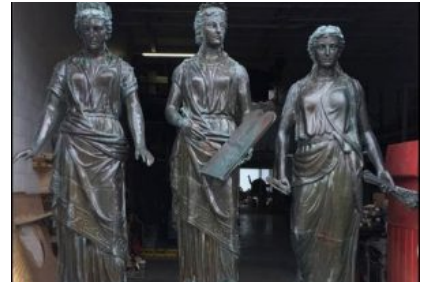
In October 2016 we completed a condition assessment survey of five (5) copper sculptures, which adorn the Franklin County Courthouse. The sculptures exhibited atmospheric soiling and bird guano, superficial oxidation of copper skin, iron corrosion staining, failed soldered seams, detachment of internal armature, deformation of sculptural elements, and loss of sheet metal at the base of the plinths.

Following the assessment, we were contracted to remove and treat the sculptures. The goals of the treatment were to stabilize the internal armature systems, restore the structural integrity of the copper substrate, reestablish the visual unity through localized repairs and spot patination, and reinstall sculptures atop the Franklin County Courthouse

The sculptures were documented, soft-packed and transported to us's facility in Maryland. The sculptures were cleaned overall to remove soiling, remnant coating layers, and loose corrosion using a dilute anionic detergent in water. After cleaning, the wood bases were removed to allow access to the internal steel "stovepipes", which were structurally reinforced; rusted internal elements were treated with a cleaner/degreaser, and a rust-inhibiting primer. The copper sheets were re-patinated to a medium brown using various concentrations and successive solutions of patina chemicals. To protect the metal substrates from oxidizing, two protective wax coatings were applied to form a barrier between the metal and the environment. Once the treatment was completed, the sculptures were soft-packed, transported to Iowa, and hoisted to the courthouse roof using two cranes.
