## Attilio Piccirilli's James Monroe Statue

JAMES MONROE'S HOME "HIGHLAND", CHARLOTTESVILLE, VA

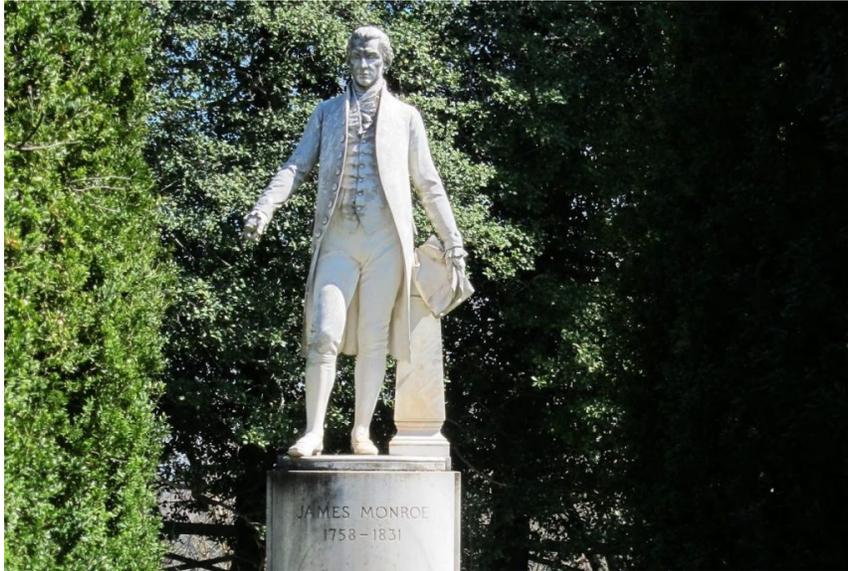
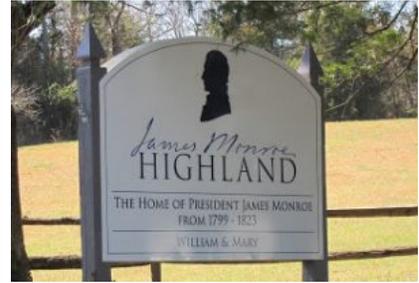
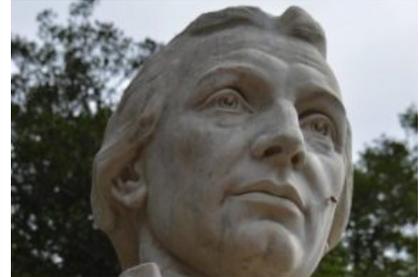
The sculpture suffered from deterioration typical of outdoor marbles. There was extensive soiling and active biological colonization on shaded areas of the sculpture that retained water. The soiling resulted in discoloration and loss of legibility of the forms. There were small cracking at the base, mortar loss, and the right fore fingertip had been previously broken off.

We performed surface cleaning on the sculpture and base to remove biological growths and surface staining. Cleaning was done through a sequence of washes and biocides following testing. After cleaning had successfully removed the worst of the soiling other repairs occurred. The salvaged broken finger was re-attached using a stainless steel threaded dowel. Cracks were filled with a custom colored grout and the joint was repointed. We also provided detailed maintenance recommendations to the client.
