Bill Blass Catalog Room

NEW YORK PUBLIC LIBRARY, NEW YORK, NY

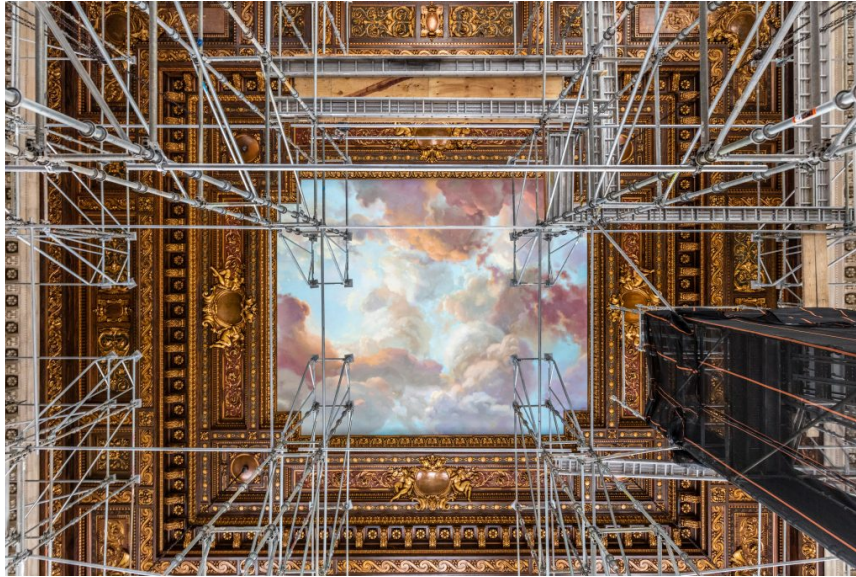
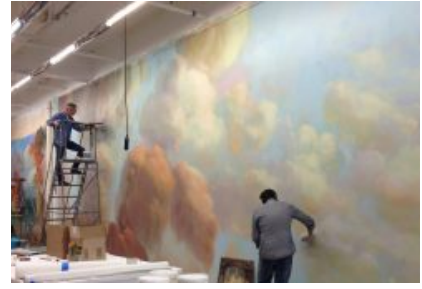
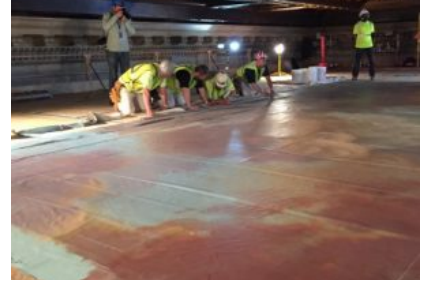
Created by James Wall Finn in 1911, the 27' by 33' mural in the Bill Blass Card Catalog Room had yellowed significantly, making the mural irreparable. Though little evidence of the authentic color palette remained, EverGreene analyzing Finn's design and used the colors present in the adjacent Rose Reading Room mural as a foundation for recreating the artwork in the Bill Blass ceiling.

EverGreene artists restored the decorative plaster and painted the sky in two large sections, uniting them on-site during installation, and returning the Bill Blass Card Catalog Room to its original elegance.
