Karl Bitter's Facade Sculptures

METROPOLITAN MUSEUM OF ART, NEW YORK, NY

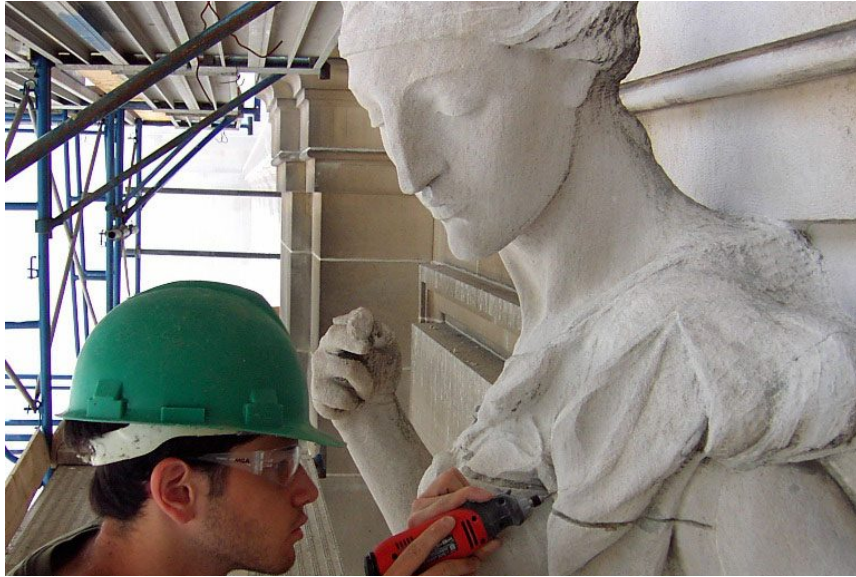
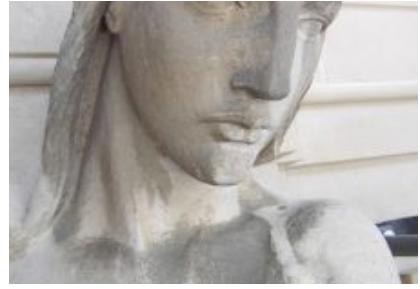
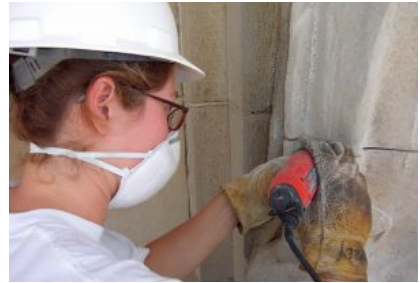
We performed a condition assessment and treatment on the limestone figures in 2005. The sculptures were washed and gypsum crusts were removed by intermittent nebulized spray. Failed mortar fills were carefully raked out without increasing the joint widths and filled with lime mortar color-matched to the stone. Fine cracks were filled with dispersed hydrated lime and capped with lime mortar. Previous inappropriate repairs were identified, removed, and repaired using the same techniques. Other repairs included replacement of losses, mortar patches, and dutchman repairs. Stone salvaged from the site was carved to replace a long-missing brush and finger on Painting.
