North & South Stair Metalwork

U.S. CAPITOL, WASHINGTON, D.C.

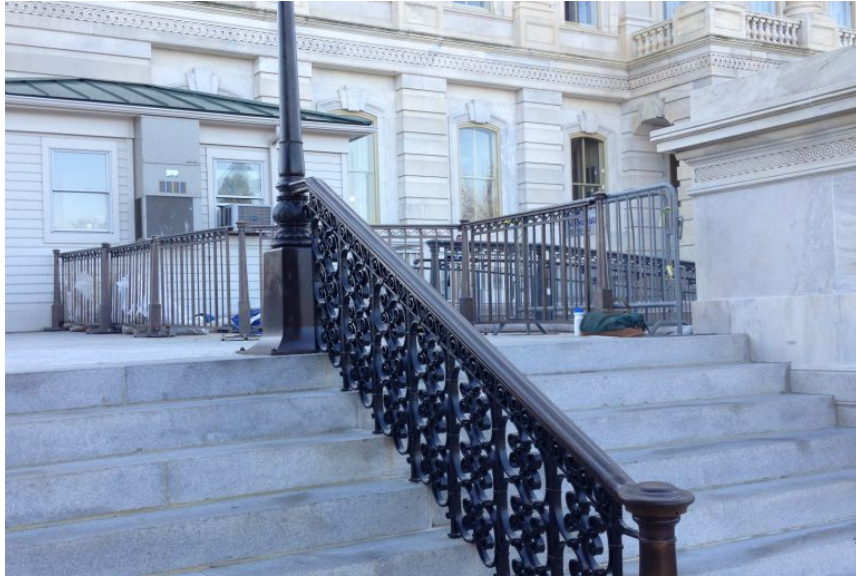
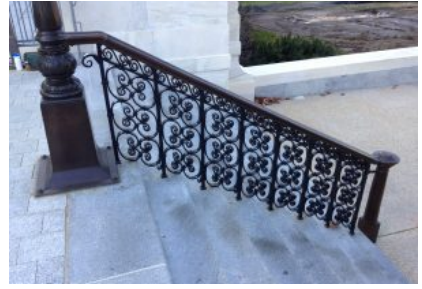
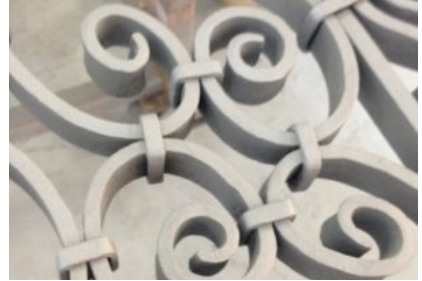
The metalwork of the north approach was treated in Fall of 2014 as part of a major restoration of the north approach masonry. The pieces were in need of cleaning and refinishing. The bronze retained no protective coating and had corroded to an overall green patina and the wrought iron railing was corroding under many layers of failing paint.

The lamppost and railing were transported to our Maryland-based studio for treatment. The bronze elements were cleaned of corrosion using a combination of laser cleaning and micro-abrasion, repatinated to a warm brown similar to other Olmsted era-bronze elements on the Capitol Grounds, and coated with an outdoor lacquer. The iron railing was blast-cleaned to remove paint and corrosion and re-finished with a high performance 3-part paint system with high UV resistance. The elements were returned to the Capitol after the completion of masonry restoration and re-installed.
