Alexander Sterling Calder's Facade Statues

I. MILLER BUILDING, NEW YORK, NY

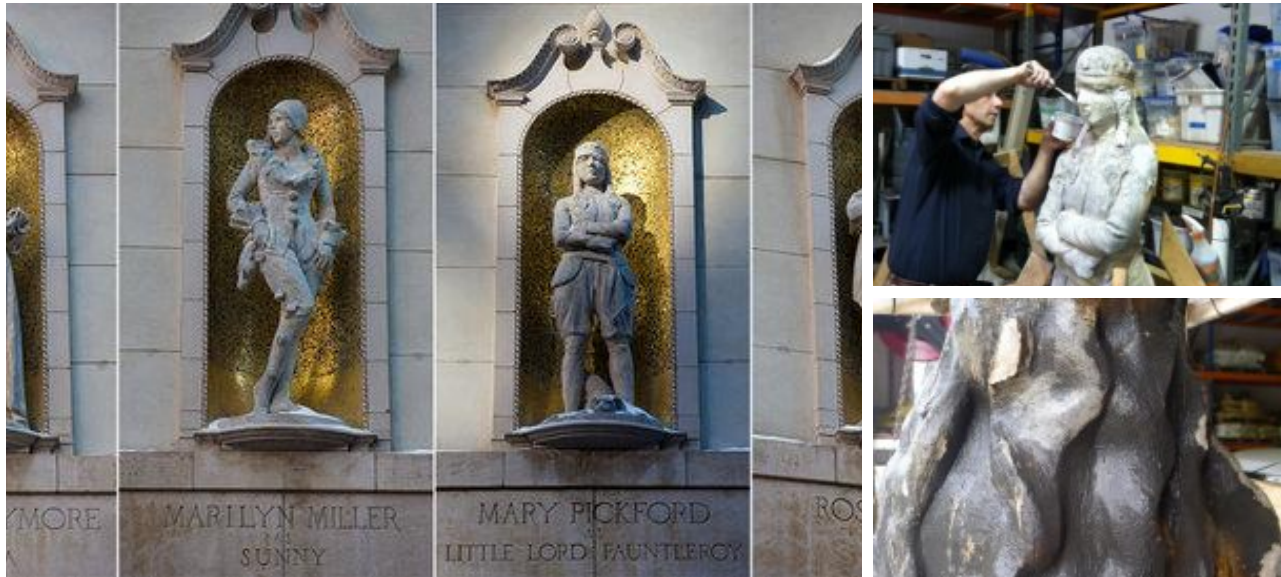
The sculptures had suffered from deterioration typical of marbles in the outdoor urban environment. Severe erosion, disaggregation, weathering and the formation of black gypsum crusts were noted on all figures. Two of the four had structurally failed. A plan was developed and restoration was scheduled for inclusion in the planned major restoration of the building.

We removed the sculptures from their niches, crated them, and brought them to our Maryland studio. Each was pre-consolidated to stabilize the extremely friable stone prior to other work. New stainless steel reinforcing has been installed within each figure to take the burden of its weight off the deteriorated stone at the legs. Cleaning has commenced with gentle cyclical water misting. After each is cleaned, losses will be rebuilt with custom formulated mortar. The gold tile mosaic niches will be restored and cleaned before each is returned to its site prior to the reopening of the building.
