Cardozo High School Mosaic

WASHINGTON, DC

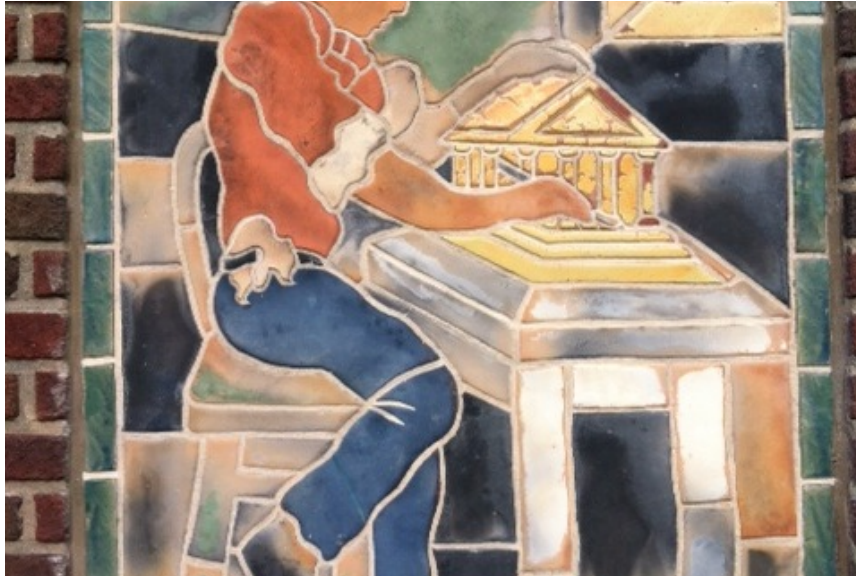
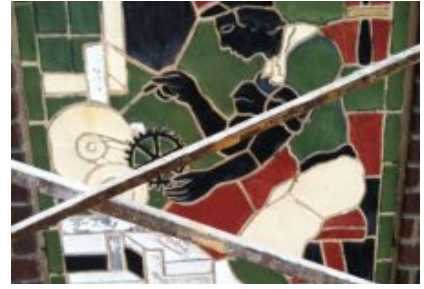
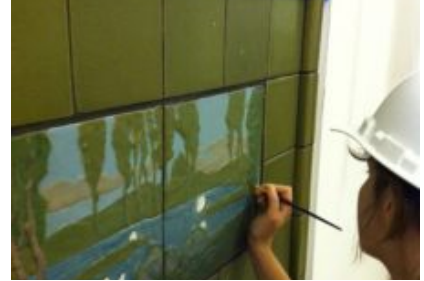
The Rookwood tiles sustained damage due to the installation of water fountains including remnant holes left from screws and pipes, cracking, loss of glaze, and chipping. Each was cleaned to remove soiling and paint. We patched the spalls and missing glaze, and rebuilt the raised ridges and texture. Each repair was in-painted to blend with the original colors. Tiles beyond repair were replaced with new tiles made by the original manufacturer. The exterior Moravian murals are exposed to the elements and showed typical signs of deterioration including atmospheric soiling, glaze loss, spalling, and mortar loss. Two of the murals had been completely painted in an attempt to conceal deterioration. Conservators removed paint and soiling, patched and painted the spalls, and repointed the tiles with mortar matching the original.
