## Cast Iron Capitals—Private

UNIVERSITY OF VIRGINIA, CHARLOTTESVILLE, VA

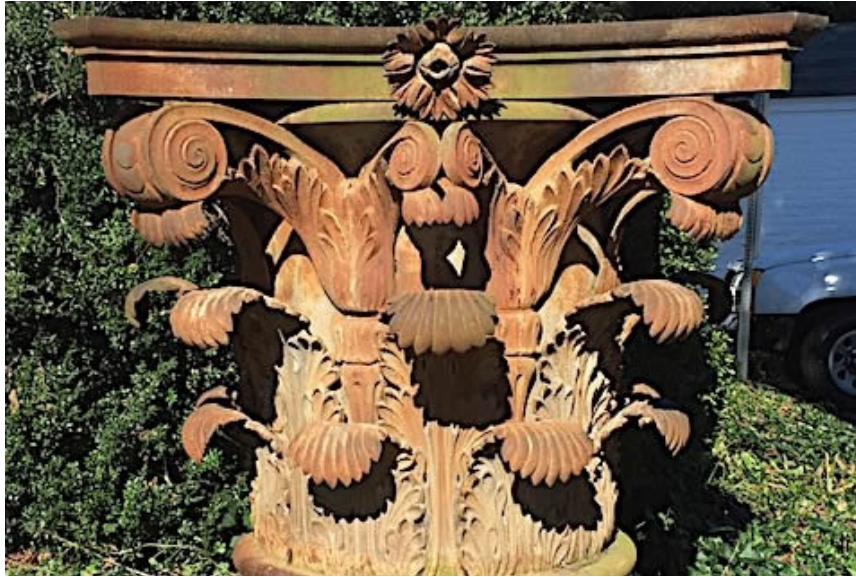
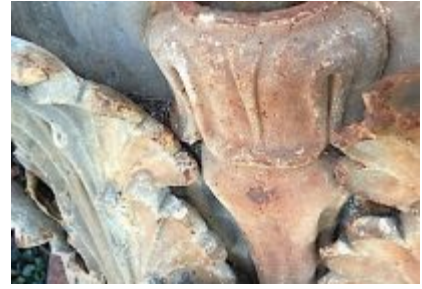
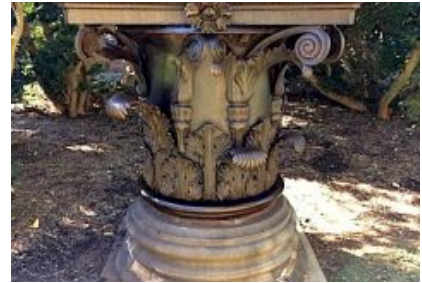
We were contracted by the University of Virginia in 2011 to perform a condition assessment and make recommendations for treatment to the five capitals, which are been displayed in shaded, damp garden settings. Without supplemental protection, the capitals were exposed to a wide range of deterioration, including soiling, flaking, cracking, and corrosion.

We mobilized in October of 2016 to treat the West Range and Monroe Hill capitals. Pressurized water was used to prepare the iron surfaces for coating. A corrosion converter was applied to create a stable iron surface. Individual elements found to be loose or missing were reattached where possible based on a case-by-case basis. Deteriorated corner volute brackets were replaced with custom stainless steel brackets.
