Centre Street Bridge Lion

CALGARY, AB, CANADA

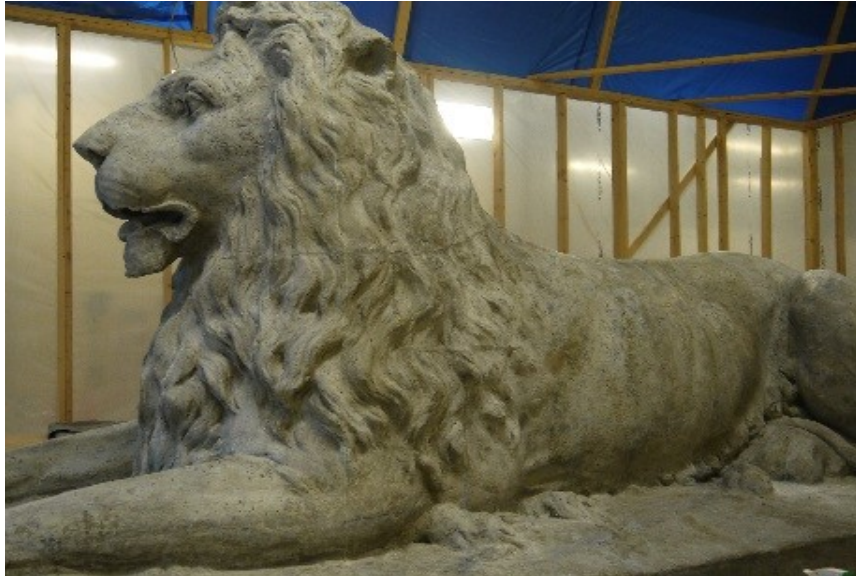
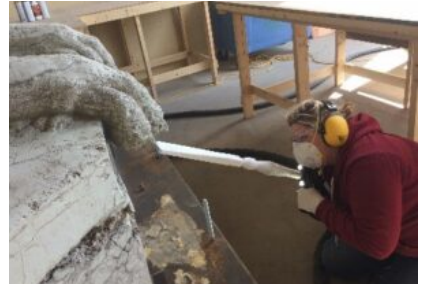
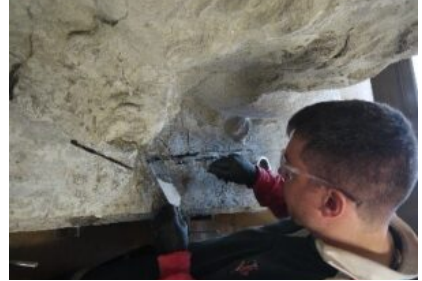
One of the four original concrete lions from Calgary's iconic Centre Street Bridge was treated in Spring/Summer of 2017. The Lion required stabilization prior to its relocation in Rotary Park where the lion will overlook the newly cast replica lions which sit atop the Centre Street Bridge. James L. Thompson, a City of Calgary employee, originally cast the concrete lions in 1916 and they were installed on top of four piers spanning the bridge's pedestrian walkways. The lions were based on the bronze lion sculptures installed in London's Trafalgar Square in 1867.

To stabilize the lion for outdoor display, our treatment involved structural stabilization using grouted sock anchors to bridge larger cracks and casting seams. To render the concrete sculpture breathable and to allow for moisture movement, the deteriorated paint coating was removed using CO₂ cleaning. The 100-year old concrete required extensive crack repair and void filling, as well as stabilization via multiple cycles of chemical consolidation. Finally, a mineral-coating system was applied to help unify its appearance and offer additional protection from weathering in its outdoor environment. The final coating system offers a semi-transparent finish so as to protect the sculpture while simultaneously preserving the visual traces of its wear, repair, and endurance over its 100-year presence atop of the Centre Street Bridge.
