Church of the Transfiguration - Lady Chapel

NEW YORK, NY

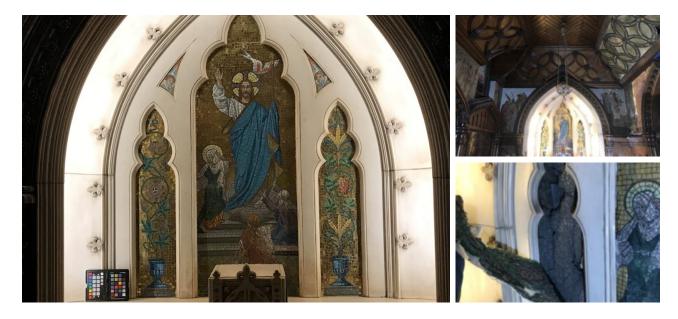
In 2023, EverGreene Architectural Arts was invited to return to the Little Church Around the corner to restore the Lady Chapel (previous work includes restoration in the chancel many years ago, and the 2015 restoration of the former baptistry, details <u>here</u>). Working in collaboration with Koutsomitis Architects PC. EverGreene was entrusted to restore the Lady Chapel's historic murals and mosaic altarpiece. The majority of the restoration process took place on site in the Lady Chapel, however sections of the murals and the mosaics were treated in EverGreene's Brooklyn Conservation Lab. The murals were water damaged, heavily soiled and had been over-painted (possibly an attempt to minimize the deteriorated appearance). The over-paint covered details and concealed the historic gold leaf background.

EverGreene conservators cleaned the murals, removed the post-historic overpaint, stabilized the original paint, in-painted the areas of loss including missing faces and re-gilded the background, restoring the murals' intended brilliance. The altar mosaics were cleaned and missing sections in-filled with color-matched, custom cut tesserae. They were re-installed on stable, reversible backing above the altar...
