## Dumbarton House Garden Niche

WASHINGTON, DC

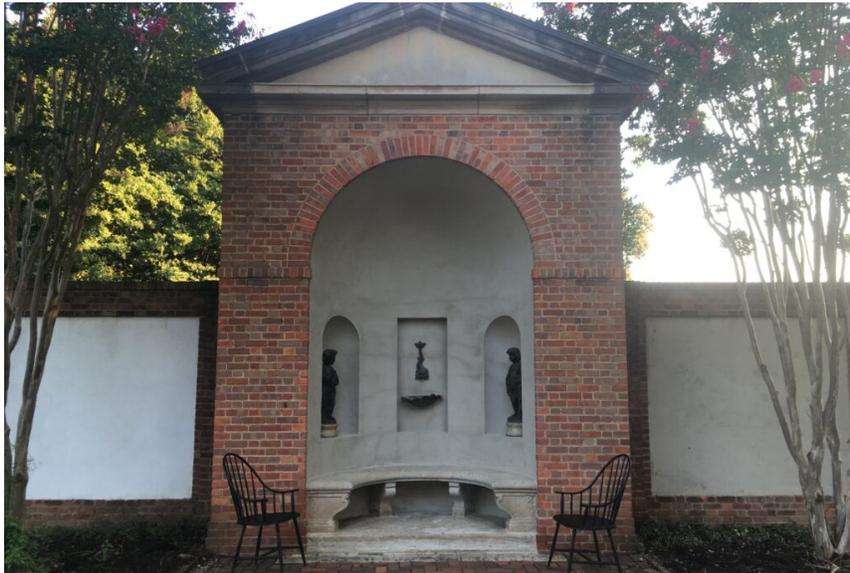
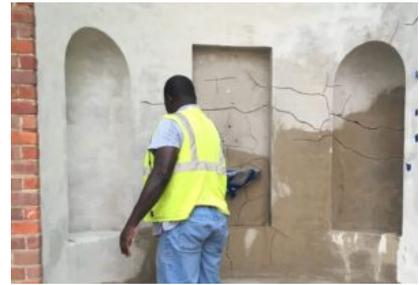
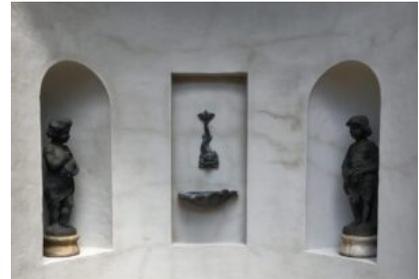
We observed that most of the limewash coating on the surface was lost, and the pointing of the Aquia Sandstone base and bench had deteriorated. There were multiple cracks throughout the niche wall and beneath the bench, where insects had nested. Additionally, the lead fish sculpture, located in the recessed rectangle, had become loose and was hanging off center.

Based on the results of our condition assessment, the following treatment plan was implemented. EverGreene directed and provided quality control for the masonry repairs on the niche, which were completed by Federal Masonry Restoration. The metal conservation included the removal, treatment, and re-installation of the lead figures. The non-symmetrical fountain bowl was covered for protection. After removing insect nests, the cracks in the wall and under the bench were filled and the niche was limewashed. The custom wash was selected based on historic documentation, which revealed that the color of the niche and walls in the house garden was intended to match the Aquia Creek sandstone architectural details, and approved by the client. Two coats of limewash were applied, and the walls were misted repeatedly for the following week to ensure that it dried properly. The deeper larger cracks dried at a slower rate than other areas because of the amount of moisture that was needed to properly in-fill them during patching. The sandstone bench and exterior base joint were repointed with a custom, color-matched mortar.
