Shipboard Radar

NATIONAL ELECTRONICS MUSEUM, LINTHICUM, MD

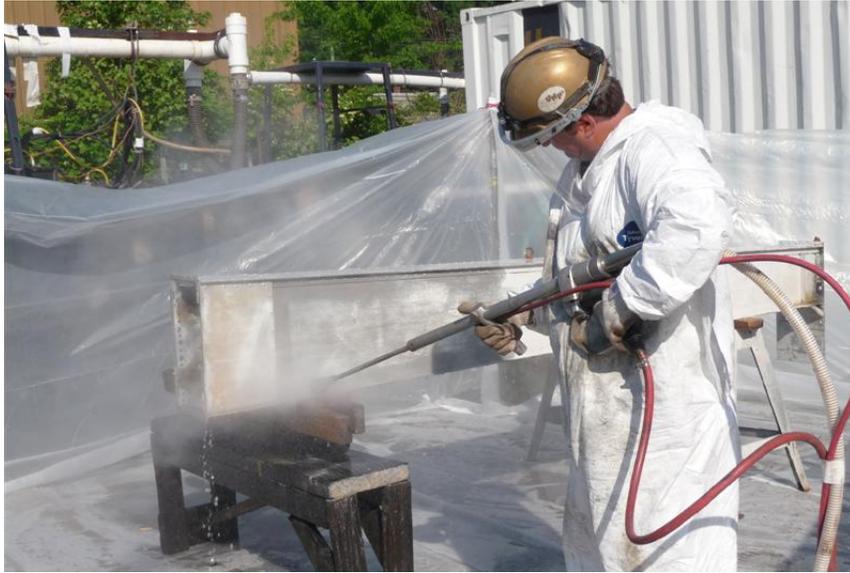
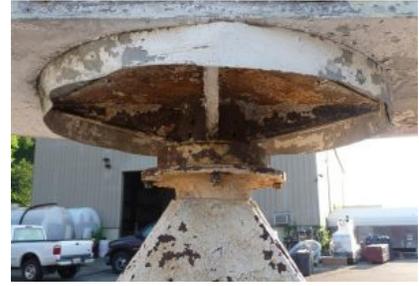
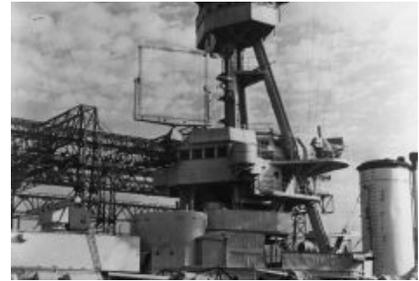
The development of radar constitutes a major milestone in modern technological and military history. Research by several prominent physicists led to the construction of the XAF radar in 1938, which became the first radar mounted on a naval vessel. The radar consists of three riveted aluminum box beams, creating a U-shaped frame, which supported the aluminum truss radar screen. This assemblage is carried on a pyramidal base, framed in steel tubes covered by sheet steel plates. Upon dismantle from the battleship, the radar was displayed in several high-traffic outdoor locations, during which time the artifact sustained significant deterioration. Aggressive corrosion of the aluminum had caused exfoliation or total loss through the metal. The steel tube framework of the base had rusted significantly, causing metal to be lost. Successive coats of white paint had failed completely and the cable mesh of the radar screen was compromised and abandoned.

We were contracted in 2009 to conserve the XAF radar. The radar was initially cleaned using high pressure (>25,000 psig) water-jetting to safely remove paint, corrosion, and salts at an off-site facility. Major areas of loss or compromised aluminum were carefully cut out and repaired with sound aluminum angle or sheet. Smaller losses and joints were filled with automotive body filler and sanded smooth. Non-original supports in the steel base were removed to facilitate repair and replacement of the original tube framework. The radar was treated with aircraft-grade metal brighteners and corrosion inhibitors to stabilize the metal surfaces. All surfaces were painted with a high-quality system of industrial finishes in a historically appropriate shade of "battleship gray".
