Fort Crawford Box Tombs

NATIONAL CEMETERIES, NATIONWIDE

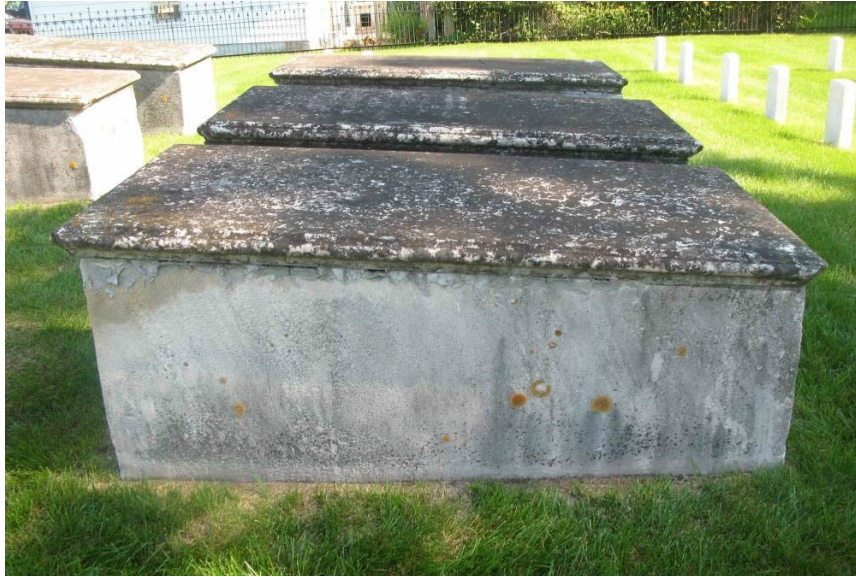
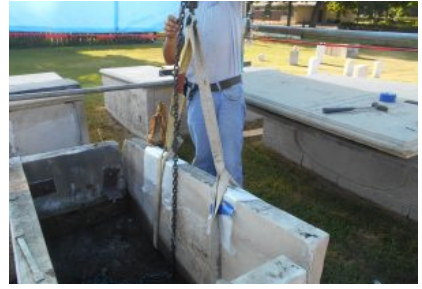
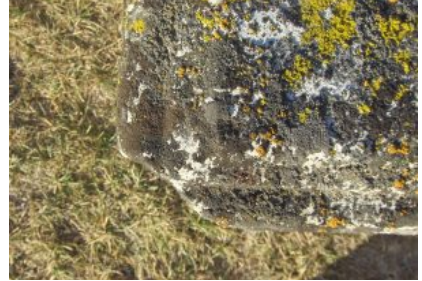
Fort Crawford Cemetery includes a small soldiers' lot that was established in 1866. It contains 8 above-ground limestone box tombs for soldiers that were probably erected by their regiments in the late 19th century. The box tombs were in various states of deterioration, several of them structurally unstable due to crumbling foundations. All were heavily soiled with biological growth, which in some cases obscured inscriptions on the tomb lids. Limestone losses and deterioration were exacerbated by a hard, unsightly grey Portland cement mortar that had previously been installed in all joints. Many moulded limestone corners were lost.

We treated six of the eight box tombs as part of a large, multi-monument contract with the National Cemetery Administration. Treatment included cleaning, patching, repointing, and resetting four of the six tombs. The limestone slabs were carefully hoisted, and crumbling foundations were excavated and rebuilt so that the tomb's walls could be reset level. The walls and lids were securely pinned back together. Fills and dutchman repairs were selectively integrated to match the original stone. Cleaning was very successful at removing the disfiguring biological growth that had accumulated, improving the overall appearance and restoring legibility of the inscriptions.
