French 18th Century Gilded Lead & Stone Fountain

WASHINGTON, DC

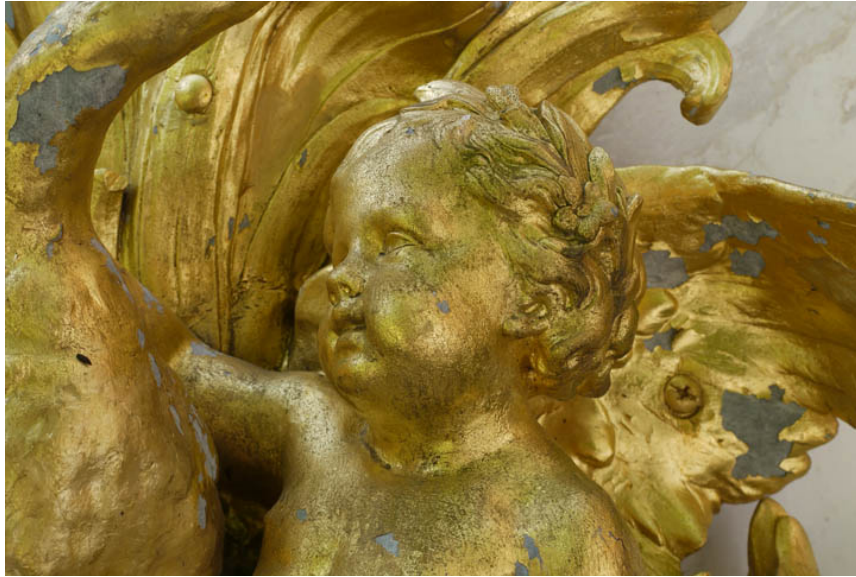
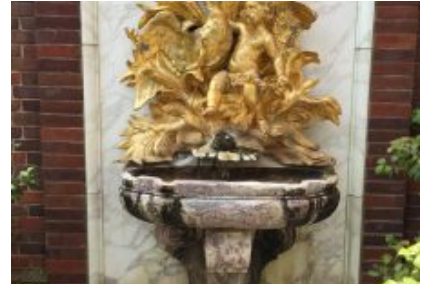
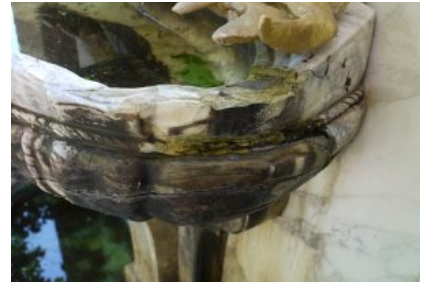
This work is characteristic of the fine craftsmanship and pleasant whimsical lighness of 18th century French sculpture and decorative arts. Built into the exterior wall of Hillwood, the Margary Meriweather Post mansion in Washington, DC, this work includes a gilded lead high-relief of a putto cavorting with a swan in a field of fronds and cat tails. It is mounted on a beautifully figured purple marble basin and stand within a pool. We were asked to study the condition of the work and provide plans to conserve the stonework and restore the gilded relief. After approval we proceeded with the work, the lead group was removed to our studios, cleaned, restored and fully regarded. The stone support and surrounds were cleaned and losses filled. A drain was added to the basin. The restored group was then reinstalled.
