Historic Vault

WASHINGTON, DC

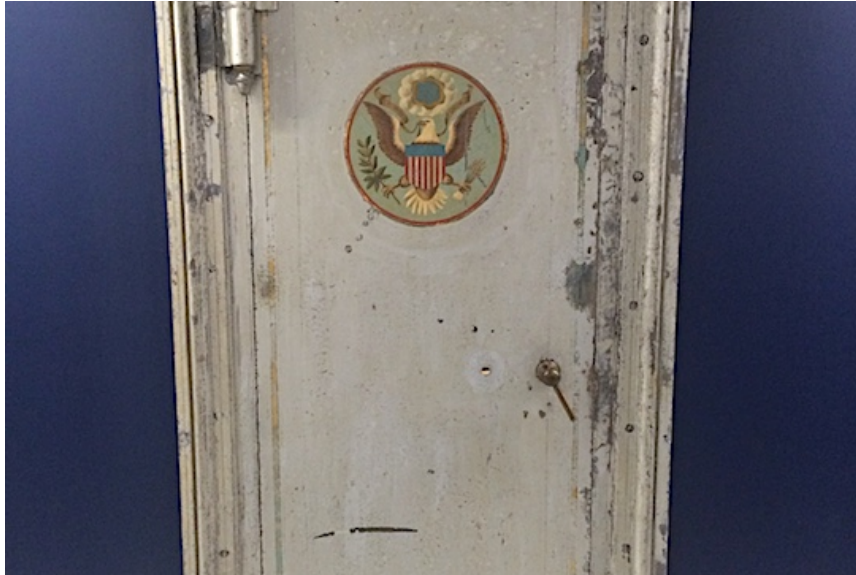
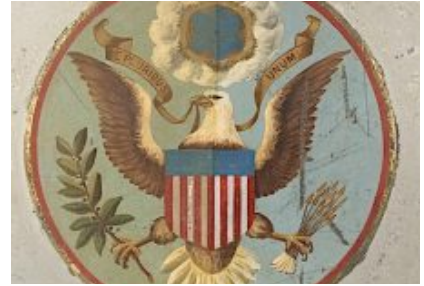
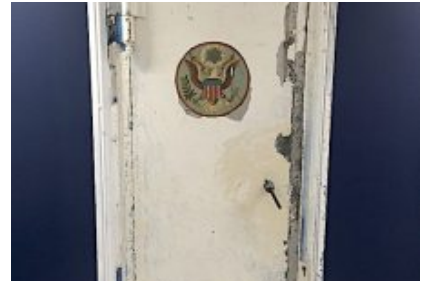
During renovations to convert the Old Post Office Building, located at 1100 Pennsylvania Avenue in Washington, DC, into a luxury hotel, a painted over vault door was found in the basement. Under the numerous layers of paint the original door was found to have intact decorative paint, including gilded moldings and a colorful Great Seal of the United States on the original steel door.

Our conservators carefully removed more than 100 years of over-paint to reveal the design. Yellow, discolored varnish was removed to reveal the original pigment colors. Losses on the Seal and areas of bare metal were in-painted. Then the aged, but intact, original paint was protected under a layer of conservation-grade lacquer.
