## Holland Theatre

BELLEFONTAINE, OH

A new chapter has been written in the Holland Theatre's history. The theatre stage was dark for part of 2018 and 2019 so the 127 East Columbus Avenue facility could be transformed to its 1931 glory through a \$1.6 million, two-phase restoration and renovation process that was made possible through generous community contributors, a regional grant and the Ohio Historic Preservation Tax Credit program.

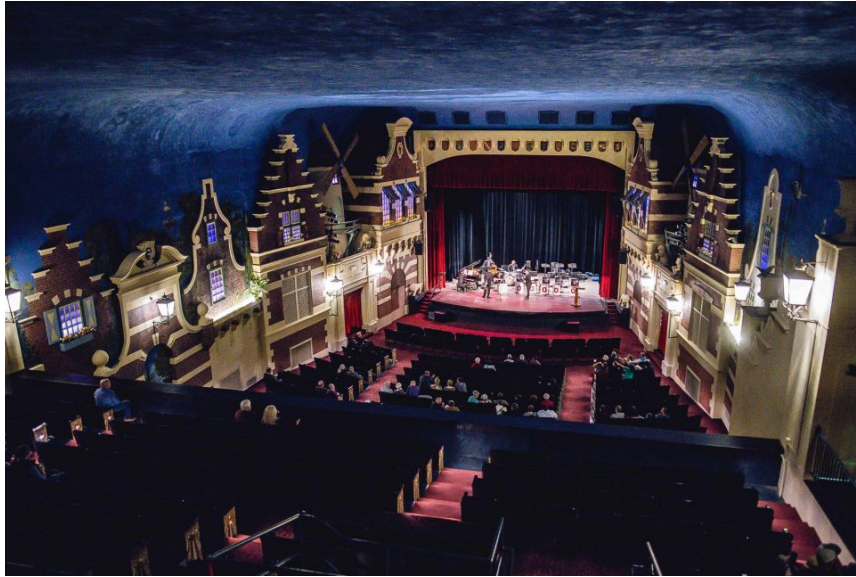
EverGreene restored both the auditorium and outer lobby. In the lobby, EverGreene's work consisted of repairing all plaster at the ceiling and beams, plaster repairs on the wall, base painting with appropriate colors, graining the beams, polychroming the medallions and using metallic paint and glazing on the poster boxes.

In the auditorium upper balcony and rear balcony, EverGreene applied faux stone ashlar, mimicking the stone-colored walls. For the rest of the auditorium, EverGreene conserved the wall murals and created a new landscape mural on canvas for "Building 9". EverGreene also cleaned, repainted, and glazed the windmills, repaired and repainted the plaster lions (which existed on two of the "Buildings").

For the Proscenium, our team cleaned, repaired, painted the new faux limestone with mortar lining and conserved the shields...
