## I. Miller Building Mosaic

NEW YORK, NY

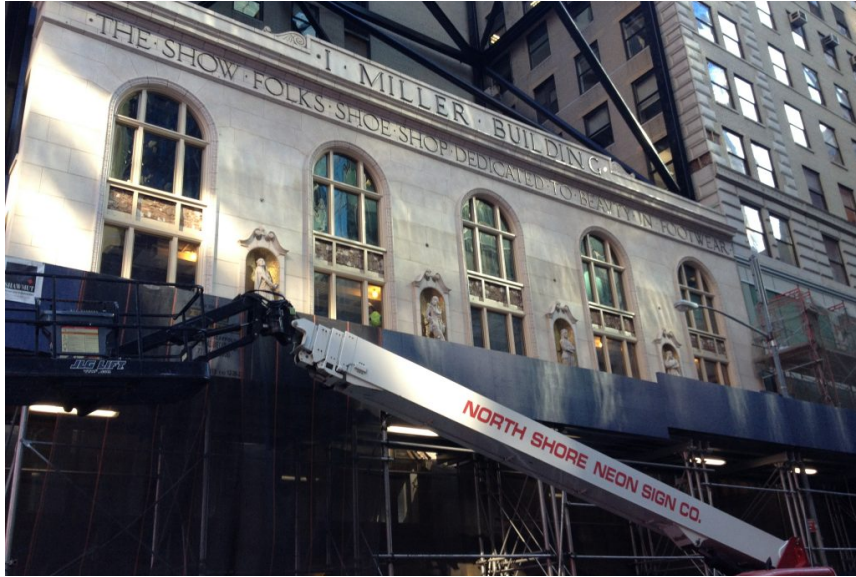
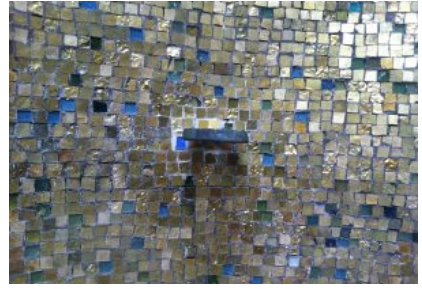
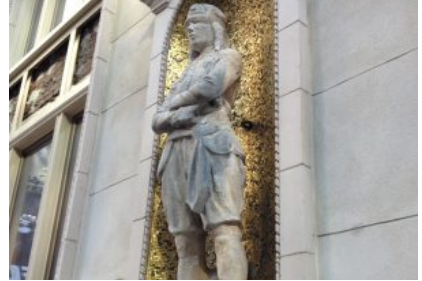
We were contracted to assess the conditions of the four sculpted figures and carry out subsequent conservation treatments, in addition to restoring the gold foil mosaic murals that lined the niches.

All surfaces were cleaned with misting and careful wiping with detergents and water to avoid detaching more glass from the embedded foil backs. Failed and lost tesserae were replaced with new gold foil backed glass which was custom cut to fit. These were set in custom formulated un-sanded modified grout. Cracks were injected with high lime grout and all missing grout was replaced with new color matched modified grout. Work was completed before re-installation of the conserved sculptures.
