## Thomas Jefferson Sculpture

COLUMBIA UNIVERSITY, NEW YORK, NY

We performed conservation treatment on the Thomas Jefferson statue in front of the Columbia University School of Journalism. Sculpted by William Ordway Partridge and erected in 1914 the bronze elements and limestone base required cleaning and conservation treatment.

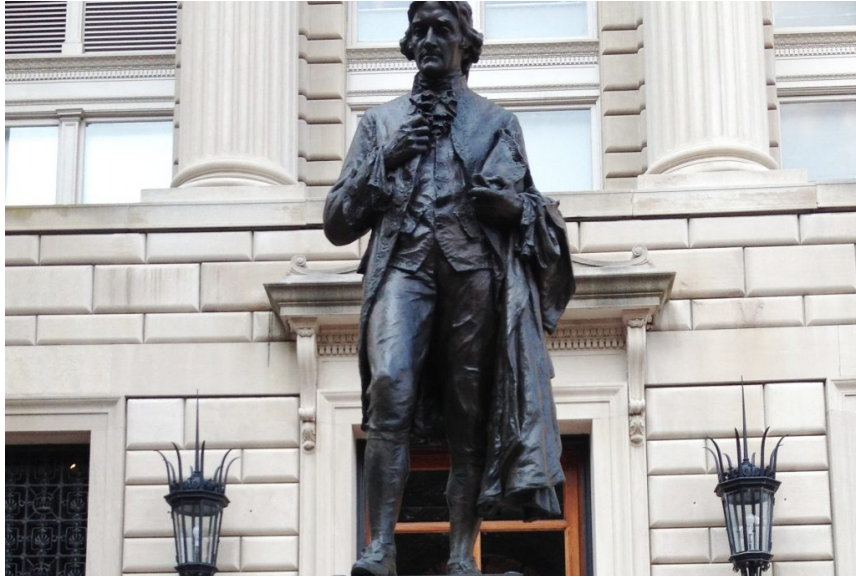
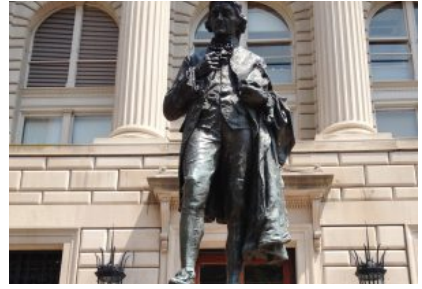
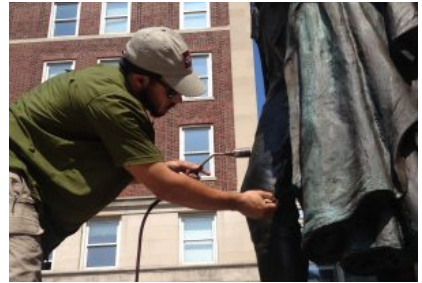
The bronze elements had experienced weathering resulting in protective wax failure, green and black corrosion. Once these elements were cleaned of failed wax and loose corrosion the bronze was spot-patinated with dilute solutions of sulfurated potash (liver of sulfur) and ammonium sulfide to create a consistent, historically accurate patina. New coatings of sacrificial wax were applied and polished. The failed joint between the bronze figure and stone base was packed with lead.

The limestone base exhibited general soiling, graffiti, areas of copper staining, and gypsum crust accumulation. The base was cleaned of soiling with a non-ionic detergent and clean water. Graffiti was removed with paint strippers. Chemical poulticing helped to reduce the copper staining and the gypsum crust was manually removed. A written plan for continued maintenance was created to help reduce future deterioration and to increase the longevity of the conservation treatment, thereby reducing future costly conservation treatments.
