Thomas Jefferson Sculpture

COLUMBIA UNIVERSITY, NEW YORK, NY

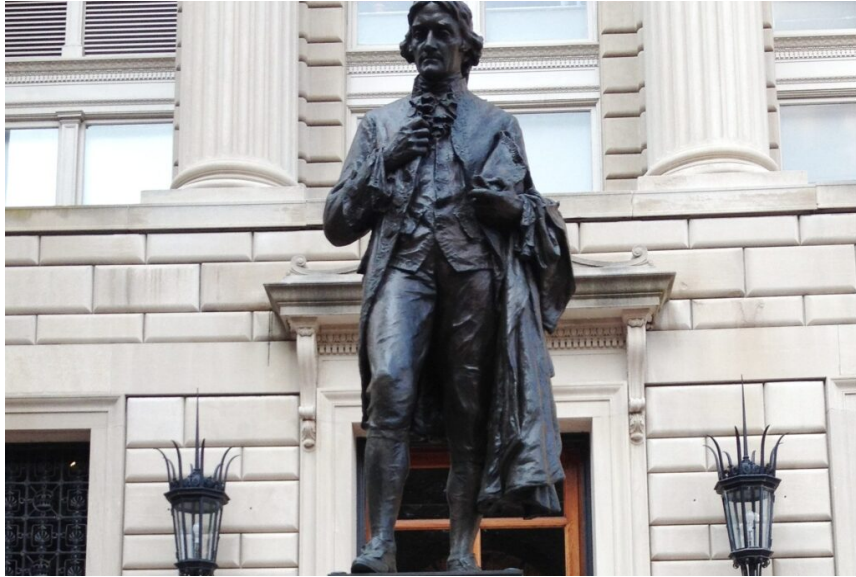
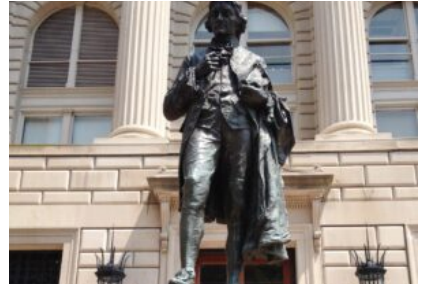
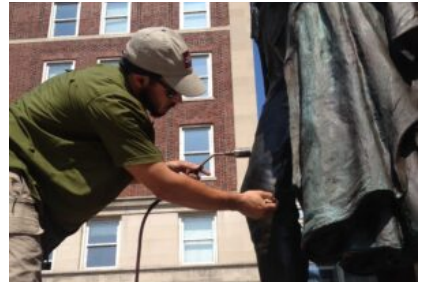
The bronze elements had experienced weathering resulting in protective wax failure, green and black corrosion. Once these elements were cleaned of failed wax and loose corrosion the bronze was spot-patinated with dilute solutions of sulfurated potash (liver of sulfur) and ammonium sulfide to create a consistent, historically accurate patina. New coatings of sacrificial wax were applied and polished. The failed joint between the bronze figure and stone base was packed with lead.

The limestone base exhibited general soiling, graffiti, areas of copper staining, and gypsum crust accumulation. The base was cleaned of soiling with a non-ionic detergent and clean water. Graffiti was removed with paint strippers. Chemical poulticing helped to reduce the copper staining and the gypsum crust was manually removed. A written plan for continued maintenance was created to help reduce future deterioration and to increase the longevity of the conservation treatment, thereby reducing future costly conservation treatments.
