Justice & Liberty Statues

CITY HALL, GOLDSBORO, NC

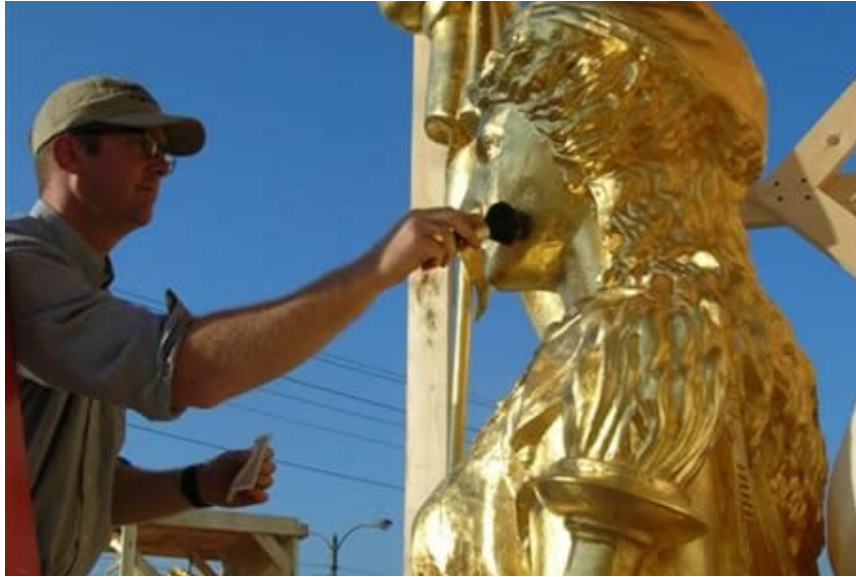
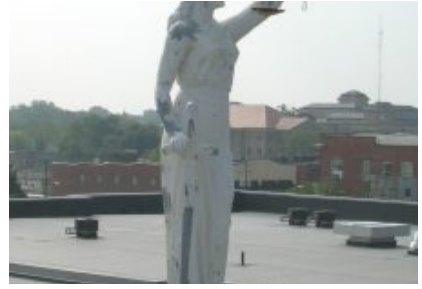
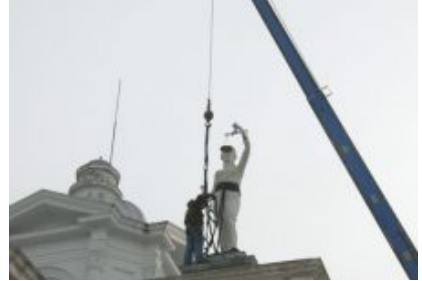
Atop the City Hall building in Goldsboro, North Carolina sit Liberty and Justice. The two figures were fabricated from zinc sheet using the repoussé and chasing methods developed by the W. H. Mullins Co. At the turn of the century. In July 2006, we were contracted to carry out a conditions assessment which included historic documentation, review of site conditions, and detailed observations of the materials and conditions of the sculptures.

Missing and damaged elements were identified and their original configuration was researched. Through microscopic examination of paint samples, conservators determined that the sculptures were originally gilded. We generated a conditions assessment report which outlined conditions of the sculptures and the likely causes for their deterioration. The report provided treatment recommendations for the preservation and stabilization of the sculptures and included a cost estimate for the proposed work.

We were then contracted to carry out conservation treatment of the statuary. The sculptures were rigged and removed from their perches, cleaned, and paint and loose corrosion removed by waterjetting. Structural supports were repaired and/or replaced, as necessary. Missing elements were modeled in clay and fabricated using original repoussé methods and the zinc skin was extensively repaired where damaged.

After repairs were completed, sculptures were coated with a high performance primer system and gilded with 23. 75 K German gold. They were reinstalled in their original locations atop the roof of the restored Goldsboro City Hall in 2007.
