Los Angeles City Hall Board of Public Works

LOS ANGELES, CA

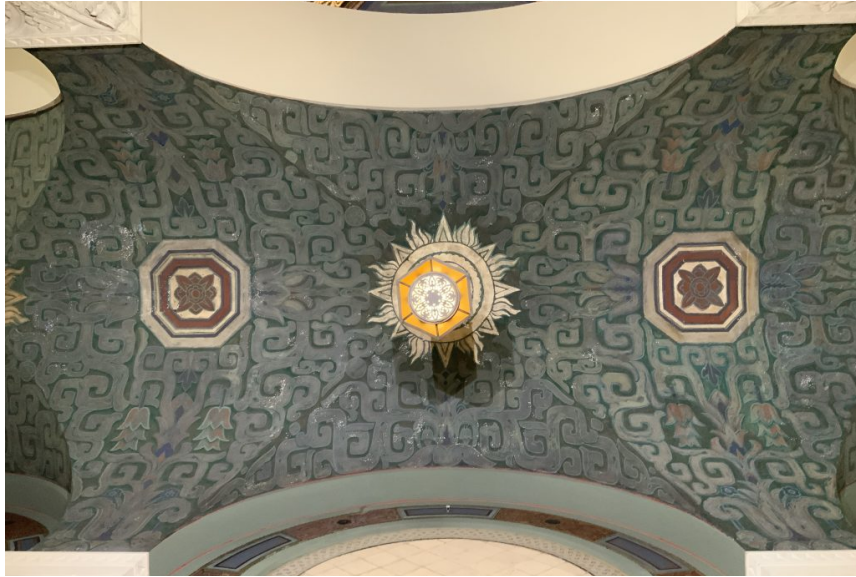
During the investigation, our team documented the conditions of the plaster and painted surfaces, carried out tests to determine the best methods of stabilizing the paint and plaster, and created treatment mock-ups in selected areas of the vaulted ceiling and decorative arches. Our primary goal during this phase was to provide recommendations and cost estimates for our future conservation and restoration work in the building. We found the paint layer in very poor condition, exhibiting both cohesive and adhesive failure due to the deterioration of the binding medium. This resulted in an under-bound and powdery paint film. This issue was exacerbated by fluctuations in temperature and humidity inside the room. Along with the decades of visitor traffic, this had caused the paint to flake and chip away.

In our second phase of work, our conservators returned to conserve the ceiling with the methodologies they recommended in the investigation phase. We began with the plaster and treated lifting areas of plaster to prevent future delamination problems, surface cleaned, and filled plaster losses to match the original surface texture. For our decorative painting and finishes scope, we repainted using a matte finish paint system and applied size and gold leaf areas of metallic finishes.
