Lion Fountain

LAS VEGAS, NM

Surveys & Condition Assessments

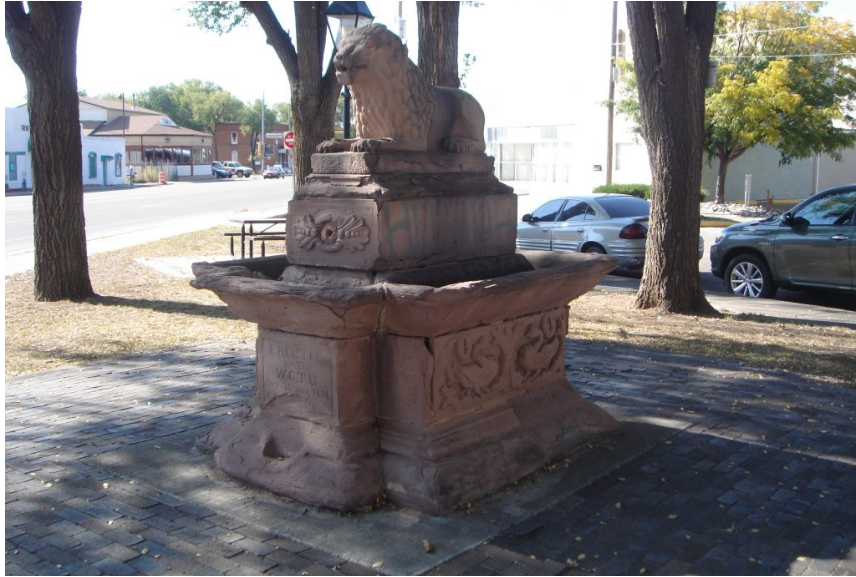
The Lion Fountain consists of a base, pedestal, basin, plinth block, and lion sculpture all carved from local reddish-brown sandstone typically referred to as "Romeroville Stone". The carving was attributed to a local artist and created circa 1896 in a traditional style using folk elements and details. The fountain is in poor condition and suffers from extensive delamination and contour scaling along the bedding planes of the stone.

We visited the Lion Park in October 2008 in order to examine the fountain and collect materials for testing. The goal of the assessment was to determine the cause and extent of the deterioration of the sandstone in order to prescribe treatments to restore and preserve the fountain. A conservation plan was developed identifying the agencies driving the deterioration of the original fountain and providing the client with a methodology to conserve the existing artifact. Due to the extent of deterioration, guidelines for disassembling and storing the original, while recreating and installing a new fountain were also included.
