Marine Garden Urns

VIZCAYA MUSEUM AND GARDENS, MIAMI, FL

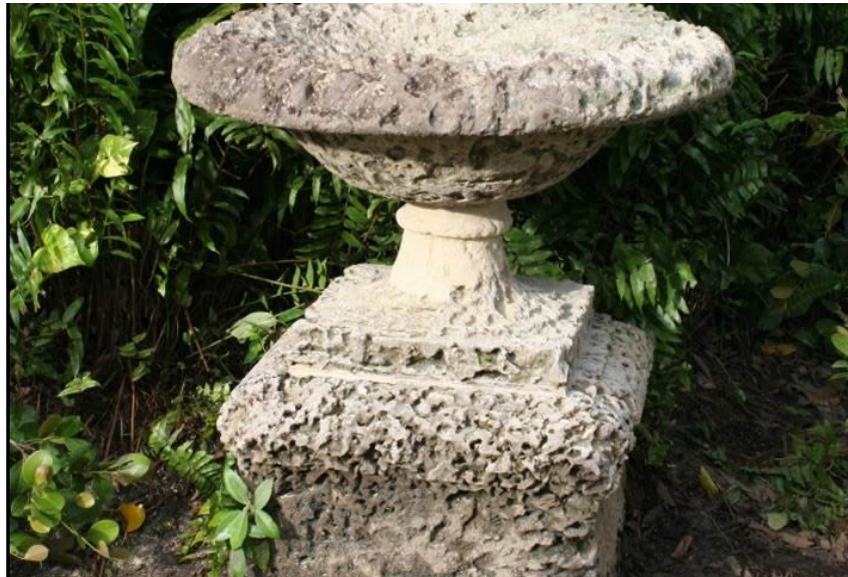
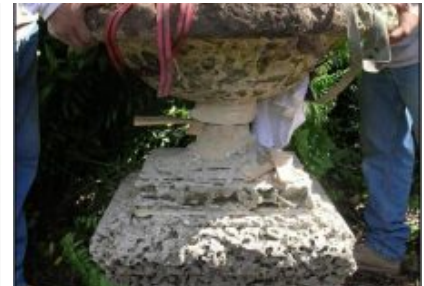
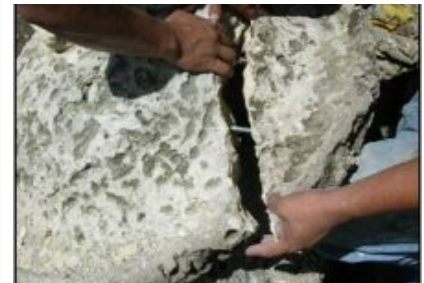
The urn, located on the north side of the Marine Garden, had been knocked over and damaged. We were contracted in 2007 to repair and reset the urn. Structural scaffolding was erected at the outset to hoist and manipulate the urn. A large, dislocated fragment of the bowl was pinned in place with stainless steel threaded rod. The bowl was then reset on its base using a new mounting pin. Following cleaning, losses around the stem were rebuilt using custom mixed mortar and tooled to match the surrounding coral stone.
