## Mexican War Monument

HARRISBURG, PA

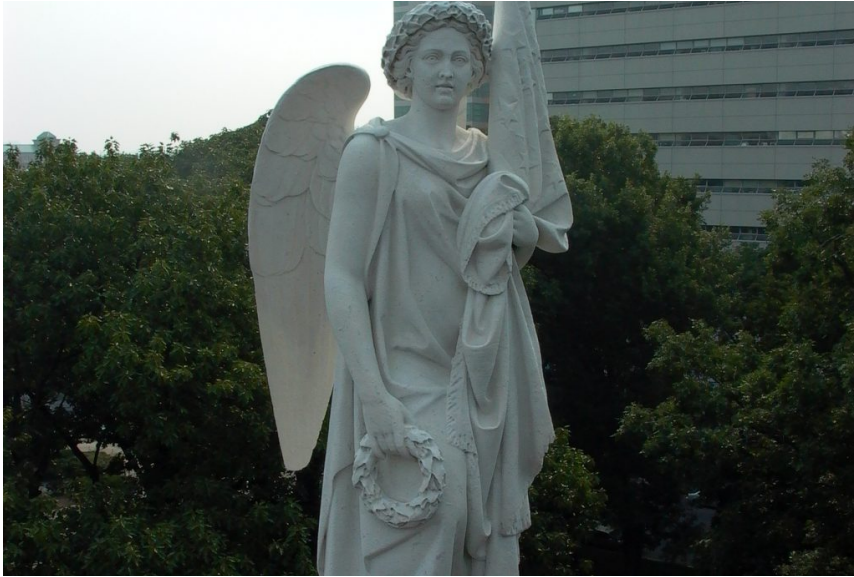
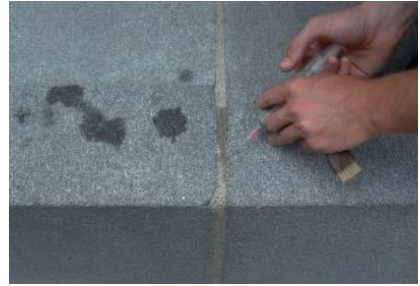
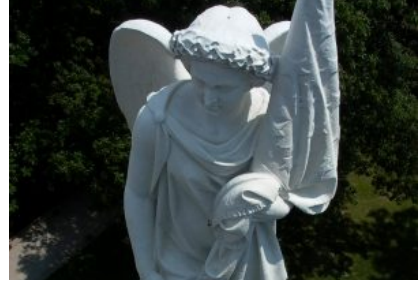
Conservation of the structure began with a thorough cleaning of the stone surfaces using an antimicrobial and non-ionic detergent and hot water. Severely weathered areas on the monument were consolidated using chemicals which help strengthen the stone and make it less susceptible to the harmful effects caused by factors which affect most outdoor statuary: weathering, biological growth, and environmental pollutants. All mortar joints were raked out and repointed using a custom color-matched mortar. Inappropriate patches were removed and areas of loss were repaired. All cracks were cleaned out and filled with an injection grout to help prevent the ingress of water. Existing ferrous panel cramps were stabilized using anodic protection that eliminated the need for a more intrusive repair. The three missing eagle heads were replicated and reattached. Three of the four granite steps surrounding the monument base were removed and reset, and corroded anchors used to attach the steps were removed and replaced with stainless steel.
