National Academy of Sciences Wood Doors

WASHINGTON, DC

We were contacted by the National Academy of Sciences to restore the west entry wood doors and bronze door surround and decorative hardware located on the National Mall in Washington, DC.

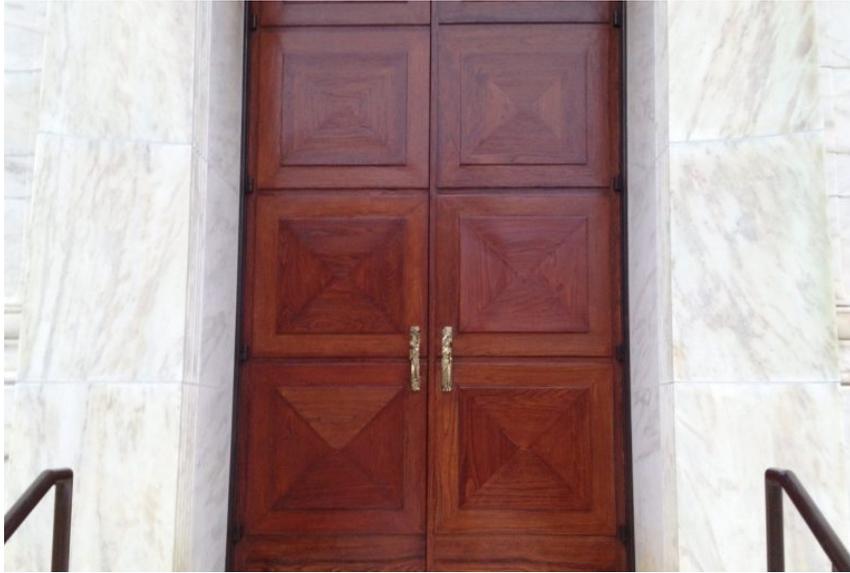
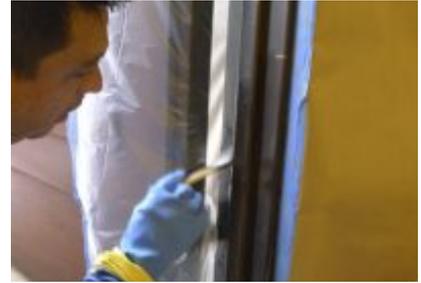
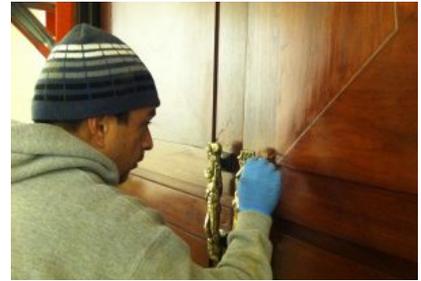
Prior to treatment, the doors exhibited conditions typical to that of wood doors in an outdoor environment. Typical conditions of the wood doors included; failed coatings, scratches/gauges, failed epoxies and composite wood fillers, substantial areas of loss, and a deformed panel. The bronze door surrounds and decorative hardware also showed signs of coating loss and corrosion.

Failed coatings were removed from the doors, scuffed areas were treated with various grits of sandpaper, and areas with failed epoxy fills were removed and prepared for in-fill with new compatible material. Composite wood filler was used to fill previous repairs and new fills. The filler was sanded down flush to the surface and stained to match the surrounding material. The deformed panel was glued and clamped closed. A new clear coating was applied to the entire door. The bronze hardware was stripped of any failed coatings, cleaned to remove corrosion/soiling, polished with abrasive pads, and coated with a clear coating.
