Peacock Columns

VIZCAYA MUSEUM AND GARDENS, MIAMI, FL

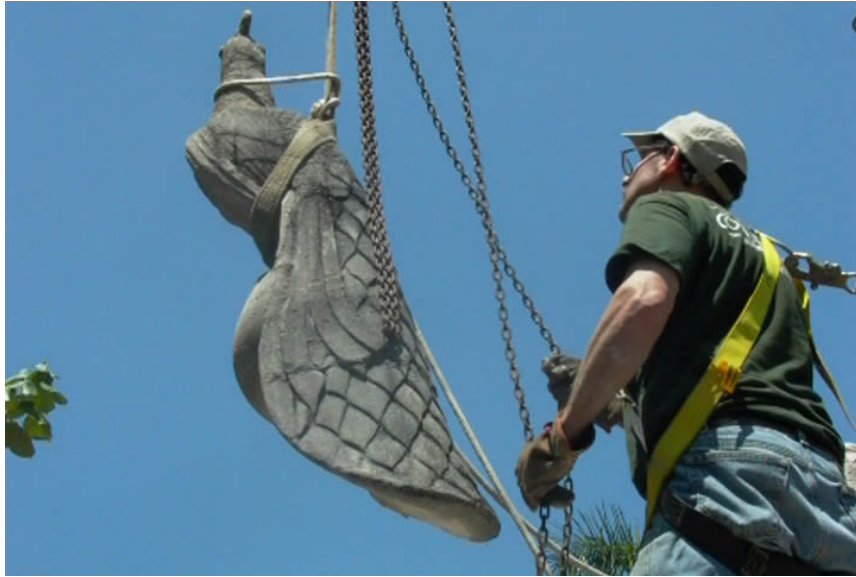
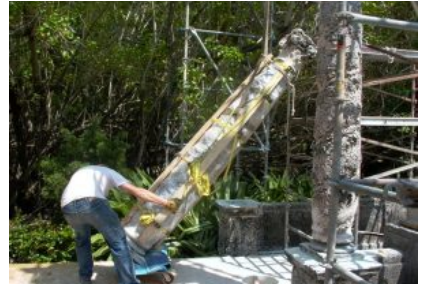
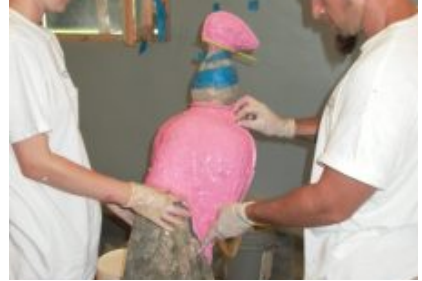
The sculptures had been repeatedly damaged by the frequent hurricanes that plague the bayside location. All had been damaged and repaired at least once in the past. Half of the columns were dismantled and further damaged when the garden site was reduced in size prior to the creation of the museum. Previous inexpert repairs had masked the original elegant designs. The columns were poorly supported and any upcoming hurricane threatened catastrophic damage.

We were contracted by the museum to remove and salvage the remaining columns and sculptures. After erection of structural scaffolding, each sculpture and column was carefully removed from its column, hoisted, and transported to secure storage. After careful research, the intact remnants of the peacocks were molded and plaster replicas were created from the fragments. These plaster replicas will be used to create replacements when the garden columns are restored.
