## PSSC Ship Copper Weathervane

MUTUAL LIFE INSURANCE BUILDING, PHILADELPHIA, PA

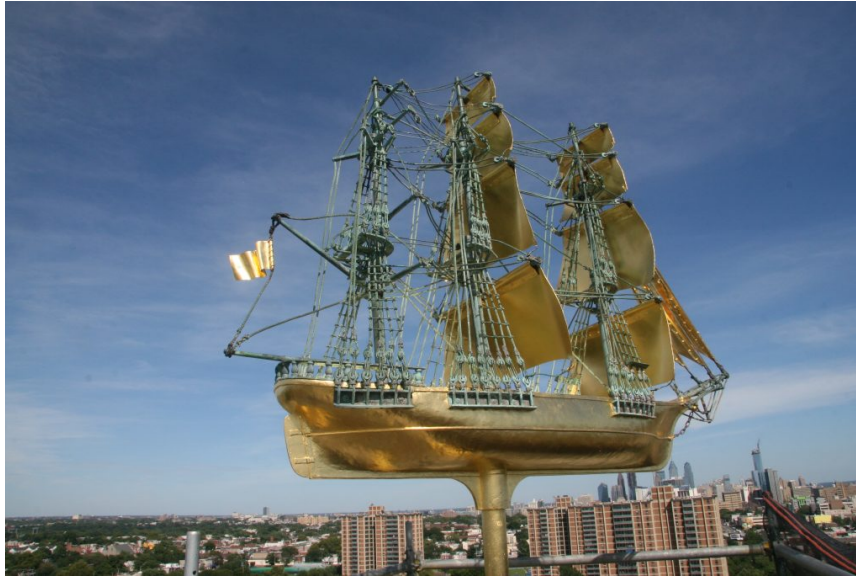
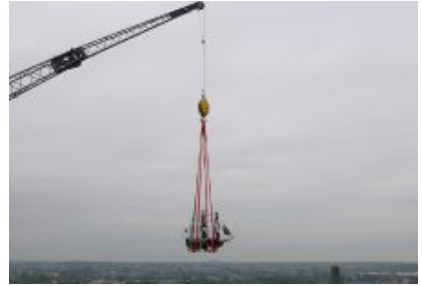
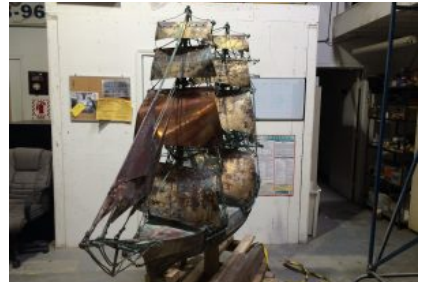
A detailed copper weathervane of a fully rigged schooner has stood on a dome atop the Mutual Life Insurance Building where it continued to rotate with the winds since installed in the 1920s. As part of the renovation of the building and conversion into a police headquarters we worked with the Gilders studio to restore the weathervane while they re-gilded it and the dome.

The weathervane was hoisted off the building and transported to us's studio for treatment. The surfaces were cleaned using water jetting followed by detailing with bronze brushes and abrasive pads. The damaged copper foretopsail was replicated and replaced in kind. Two rigging lines were replaced with copper cable while others were repaired with solder. The flag was repositioned to face the proper direction. The solder and repairs were then patinated to match the existing cupric green color and coated with lacquer. Gilders Studio then re-gilded the hull, sail and other elements before it was again hoisted and reinstalled atop the building.
