## Rose Garden Fountain

KYKUIT, THE ROCKEFELLER ESTATE, TARRYTOWN, NY

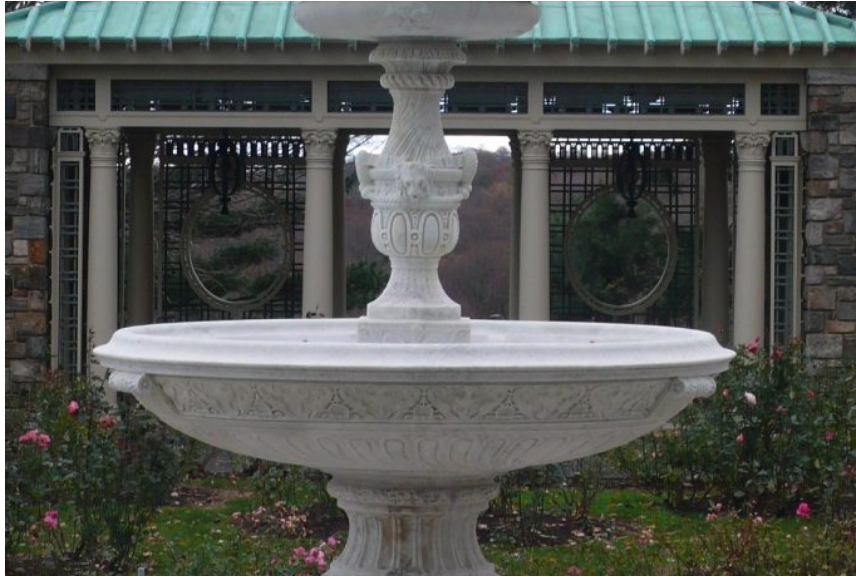
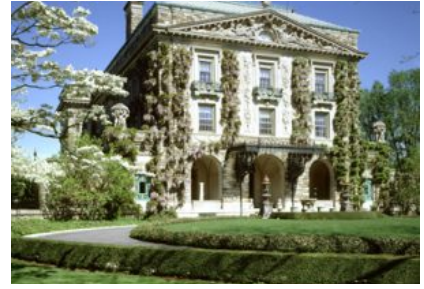
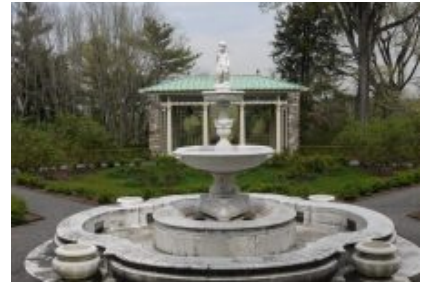
These stones suffered from an endemic network cracking and some structural failures that have been found on other Carrara marble monuments in America from the same period. A pattern of fine cracks had formed in several blocks, literally fracturing the stone in a cubic network. In addition to this, structural cracks had formed on both basins. Prior repairs had aged and the marble required cleaning and stabilization.

We surveyed the fountain, prepared a series of treatment recommendations and performed the work. The fountain was disassembled at an old break, reinforced, and reassembled with the putto and goose statue facing in a corrected orientation. After a series of cleaning procedures, the fine cracks were filled with a custom color-matched grout. Old repairs were redone, the statue was consolidated, and a new 316L formed ring was installed within the lower basin to reinforce it.
