Salem Justice Statue

CASCADE COUNTY COURTHOUSE, GREAT FALLS, MT

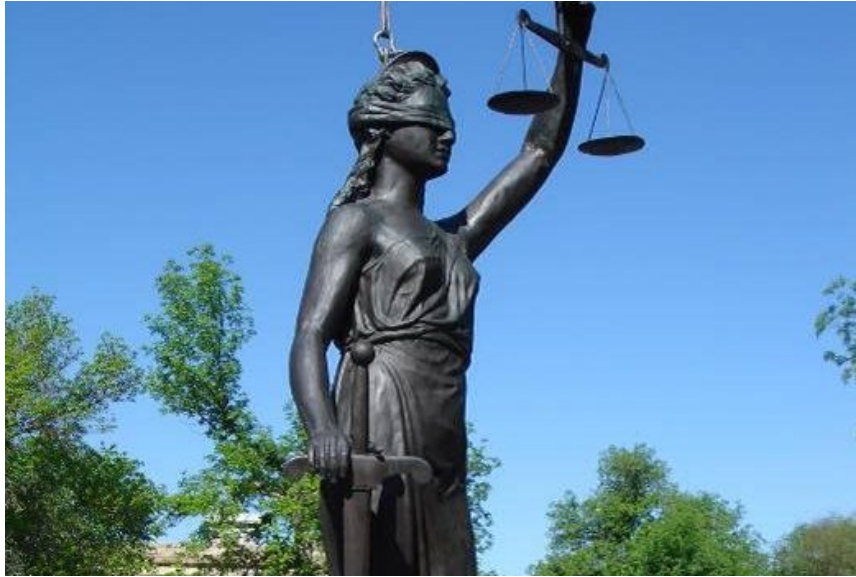
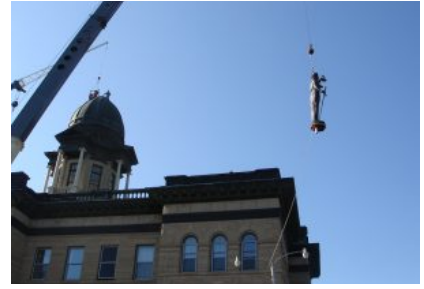
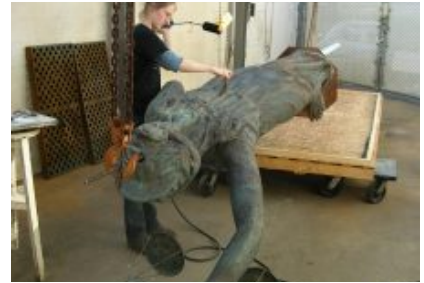
Their copper figure of Justice had stood atop the Cascade County Courthouse dome in Great Falls, MT for more than 100 years before it was toppled in a windstorm in 2004. The original mountings sheared off and the copper skin was severely damaged in the resulting fall. Elements were deformed and lost and the original structure could no longer be used in remounting.

We were contracted to restore and remount the salvaged work of art. Using our expertise in sheet metal sculpture conservation, conservators restored or recreated all of the damaged or missing copper elements. Working with the courthouse's architect, a new structural system for the statue's interior and mounting for the dome were designed, fabricated and installed so as to maximize stability and minimize potential galvanic corrosion. The copper was then patinated to match the conditions prior to the damage, crated, shipped and reinstalled atop the courthouse in 2006.
