Smithsonian Institution Arts & Industries Building

WASHINGTON, DC

Conservation Treatments
Metal Conservation–Draft

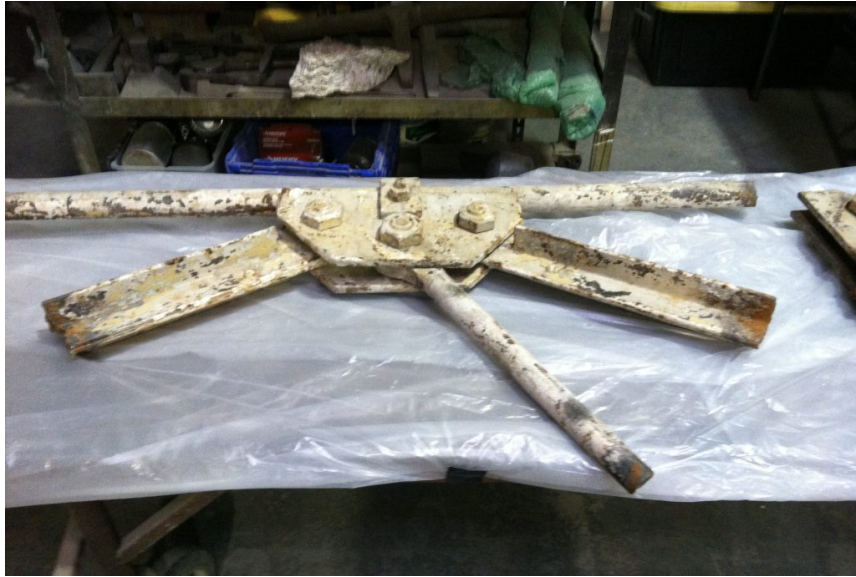
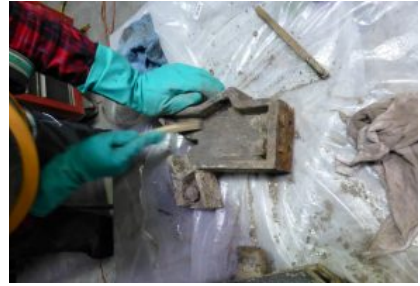
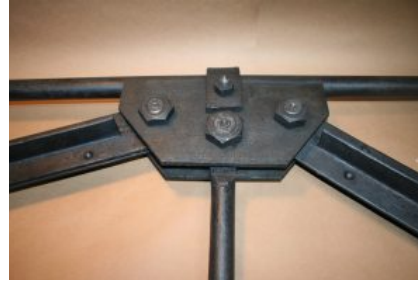
The Arts and Industries Building of the Smithsonian Institution, the second oldest building on the National Mall, underwent major renovations and maintenance beginning in 2004. The building's roof was replaced as part of this maintenance. A fragment of the original iron roof truss and three accompanying architectural elements were salvaged and sent to us for treatment.

Paint was carefully removed from the surface of these elements using a chemical solvent-based stripper with nylon brushes and pads. Active corrosion uncovered when the paint was removed was stabilized by application of a tannic acid-based corrosion converter which reacted with active corrosion products to produce stable iron tannates. Finally, a coat of microcrystalline hot wax was applied to protect the surface of each element.
