Tennessee Memorial Arch

NATIONAL CEMETERY, CHATTANOOGA, TN

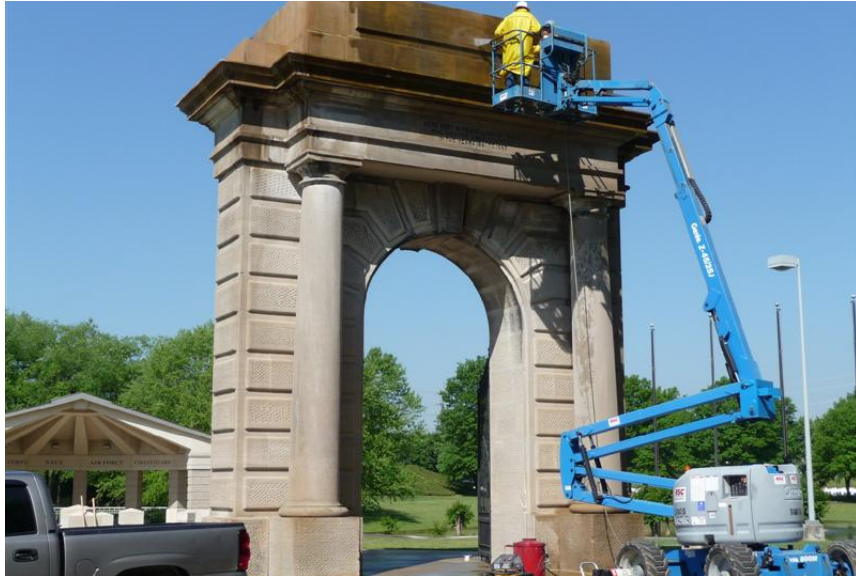
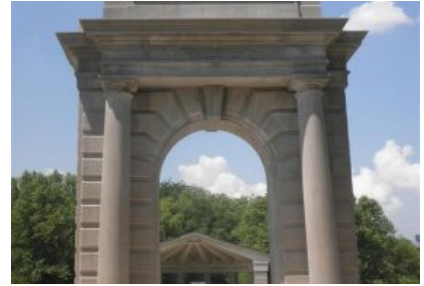
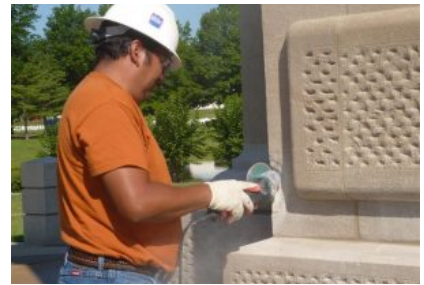
The limestone arch suffered typical deterioration for its age. This included stone and mortar loss with 100% joint failure in the attic and cornice area, and 60% failure in the lower portions. The attic and arch base had also accumulated thick biological soiling in addition to the atmospheric soiling on the limestone. The attached iron gates showed failed and ineffective repairs.

We were contracted to perform the stone cleaning, repairs, and re-pointing, working with a subcontractor to fix and refinish the iron gates. Through testing, an effective but sensitive process was developed to provide a general cleaning, as well as to remove the carbon soiling, tar, and paint. Failed mortar joints were re-pointed, using a closely-matched mortar, and all skyward-facing joints in the attic and cornice were protected with lead T-caps. Stone repairs were performed through grout injection into existing cracks, and by patching areas of significant deterioration/loss. Previous poorly executed weld repairs on the iron gates were ground and re-welded, and missing or bent hardware was replaced before the entire assembly was repainted using a high performance system.
