Bronze Lampposts, Handrails, & Urns

U.S. CAPITOL, WASHINGTON, D.C.

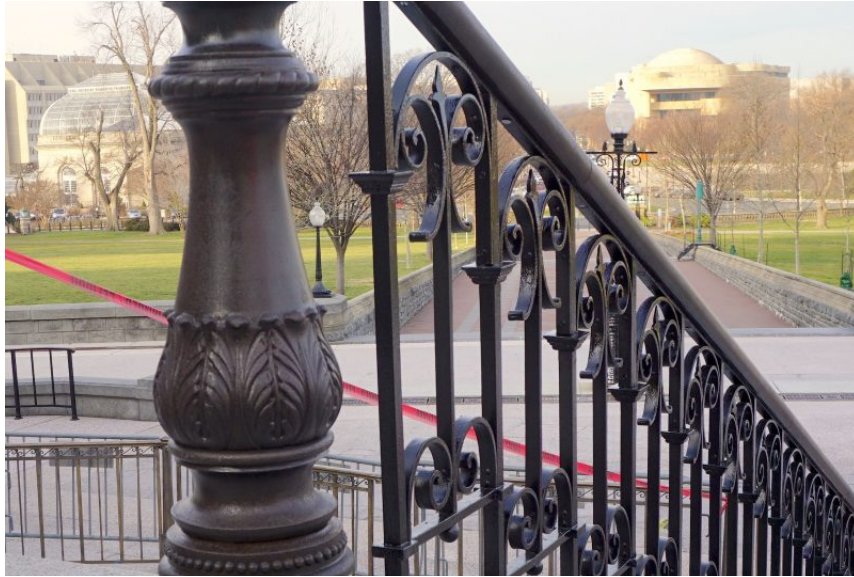
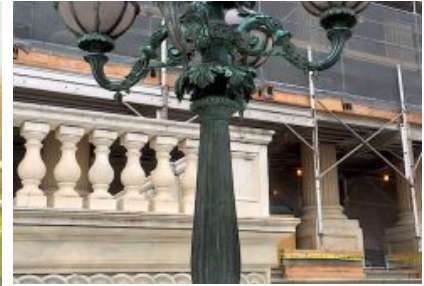
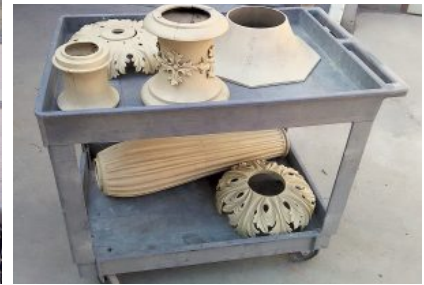
Our conservators were contracted to assess and treat two handrail sets, two lampposts, twelve urns at the north and west facades of the Capitol. The bronze surfaces had developed a thick deposit of light green corrosion product on their surfaces. The goal of the treatment was to clean and refinish the bronze surfaces, in addition to repairing the cap and newel posts, and rewiring the lampposts.

Treatment of the bronze elements included removing them from the site, cleaning existing corrosion, patination, and application of a protective lacquer coating. Minor repairs included filling of cracks with bronze-bulked epoxy and filling of holes with threaded bronze rod. The bronze was patinated to match the reddish-brown patina seen on other bronze elements throughout the Capital grounds. After treatment, all elements were reinstalled in their original locations. Our conservators provided detailed documentation of all conservation processes as well as maintenance recommendations.
