## Balustrade Restoration

DEPARTMENT OF VETERANS AFFAIRS BUILDING, WASHINGTON, DC

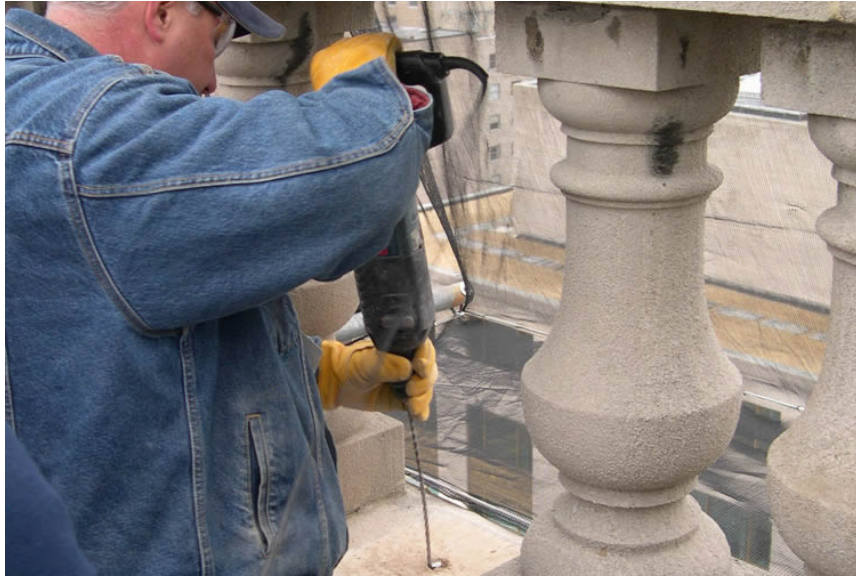
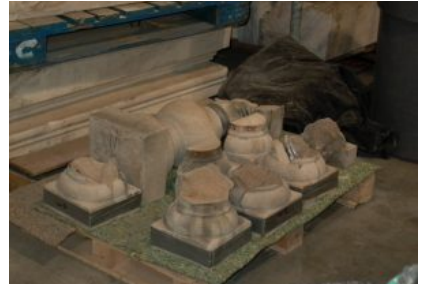
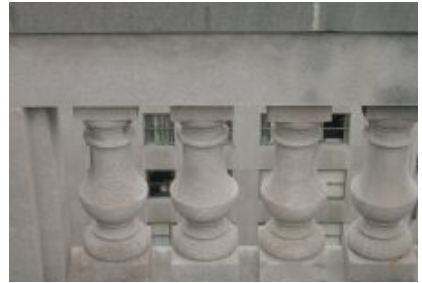
Iron pins centered on each of the balusters had deteriorated and expanded, splitting a number of the massive limestone turnings. The most urgent goal was the removal of any life/safety threats posed by the balusters. Each damaged baluster was carefully cut out by raking and saw cutting of the mortar. Next, the sources of the damage, embedded iron pins and failed skyward facing coping joints, were replaced or restored. New limestone balusters, exactly matching the originals, were turned and either replaced in total or fitted to the originals as dutchman repairs. Restored balusters were then replaced in the parapet using new stainless steel custom fabricated drop anchors. The joints were then painted to match the existing historical mortar and lead caps were installed atop the upper joints to eliminate further water infiltration.
