## Vicenza Sculpture

DELBARTON SCHOOL, MORRISTOWN, NJ

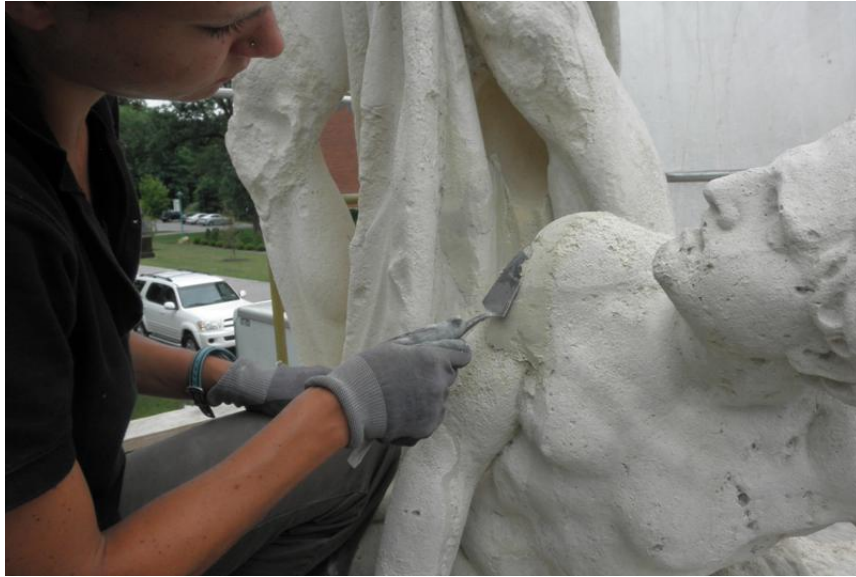
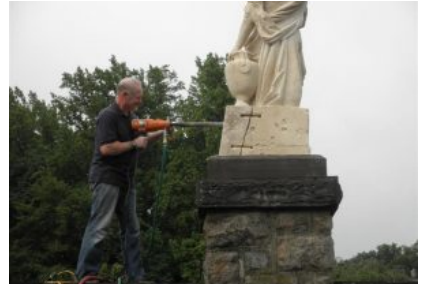
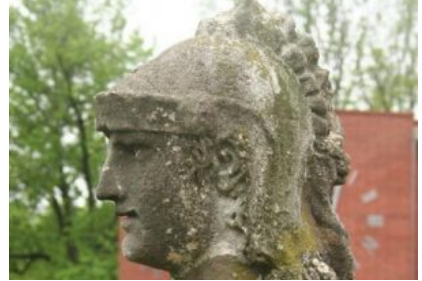
The sculptures had accumulated significant and disfiguring soiling and biological growth from their exposure to the outdoor environment. Cracks and minor losses, as were specific areas of deep loss, and structural and/or aesthetic failure of previous repairs were endemic. We cleaned and conserved the sculptures in 2011. General and detail cleaning were performed to remove the soiling and bio-growth. Failed previous repairs were removed or reworked. Friable stone was consolidated through the use of a slurry coat, larger fragments were reattached, and elements that required additional internal support were pinned using the appropriate system. Significant losses – those on skyward-facing surfaces that could become water catch-points and voids from pinning campaigns – were selected for patching with sympathetic color-matched mortar. Conservators also injected cracks and repointed the joints of the plinth.
