Bacchus Fountain

VIZCAYA MUSEUM AND GARDENS, MIAMI, FL

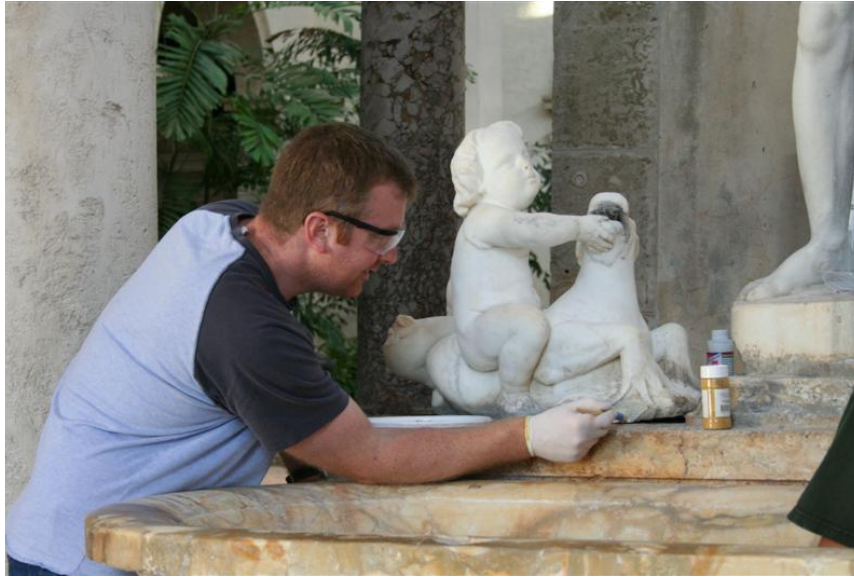
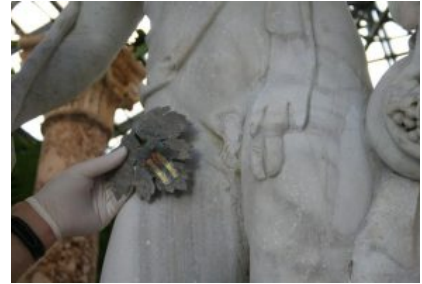
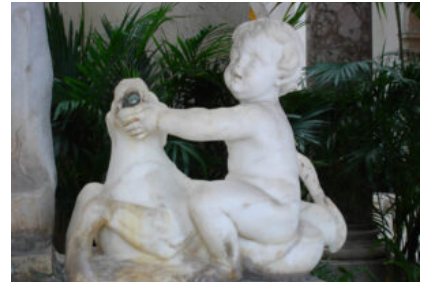
Nearly 100 years of use had taken its toll on the fountain. The putti and figure were soiled and previous repairs had begun to fail. Regular floor maintenance had damaged the verd antique pool lip. The color and detailing of the yellow marble basin was entirely hidden by a whitish haze from hard water deposits from the water that flowed across its surface.

We were contracted to restore the fountain in 2007. After careful detergent cleaning to remove soiling, the failing fills were replaced with appropriately formulated lime mortars. The losses in the verd antique pool were rebuilt with color-matched scagliola mortars and toned to match the figured stone. The lime deposits were carefully removed by multiple repeated applications of gelled solutions and hand scrubbing. Protective color-enhancing coatings were then applied to protect the stone and a comprehensive treatment report was submitted.
