## Bacchus Fountain

VIZCAYA MUSEUM AND GARDENS, MIAMI, FL

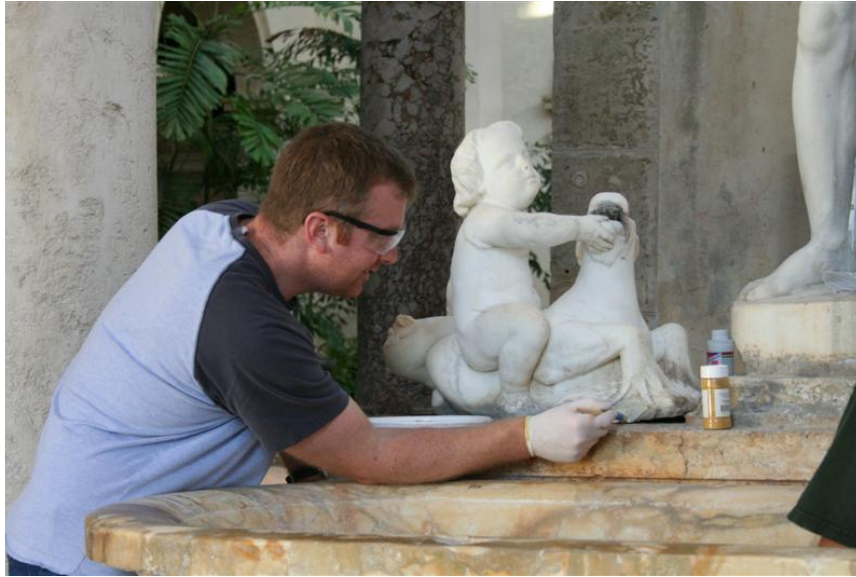
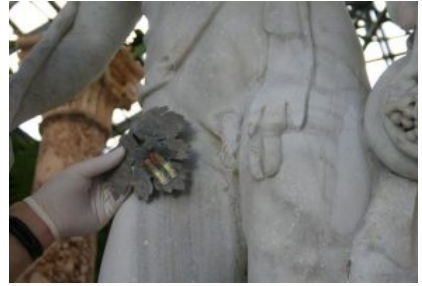
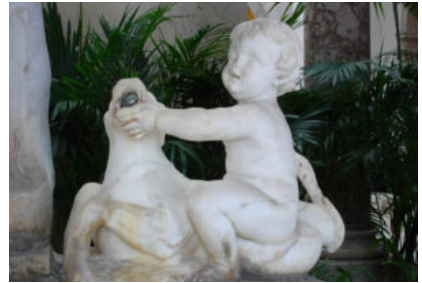
Nearly 100 years of use had taken its toll on the fountain. The putti and figure were soiled and previous repairs had begun to fail. Regular floor maintenance had damaged the verd antique pool lip. The color and detailing of the yellow marble basin was entirely hidden by a whitish haze from hard water deposits from the water that flowed across its surface.

We were contracted to restore the fountain in 2007. After careful detergent cleaning to remove soiling, the failing fills were replaced with appropriately formulated lime mortars. The losses in the verd antique pool were rebuilt with color-matched scagliola mortars and toned to match the figured stone. The lime deposits were carefully removed by multiple repeated applications of gelled solutions and hand scrubbing. Protective color-enhancing coatings were then applied to protect the stone and a comprehensive treatment report was submitted.
