West Virginia Capitol Dome

CHARLESTON, WV

The West Virginia State Capitol was designed by Cass Gilbert in Italian Renaissance and Colonial Revival styles. After eight years, the building was completed in 1932, and added to the National Register of Historic Places in 1974. EverGreene investigated, tested, and assessed conditions of the interior and exterior dome, which we were brought back to restore.

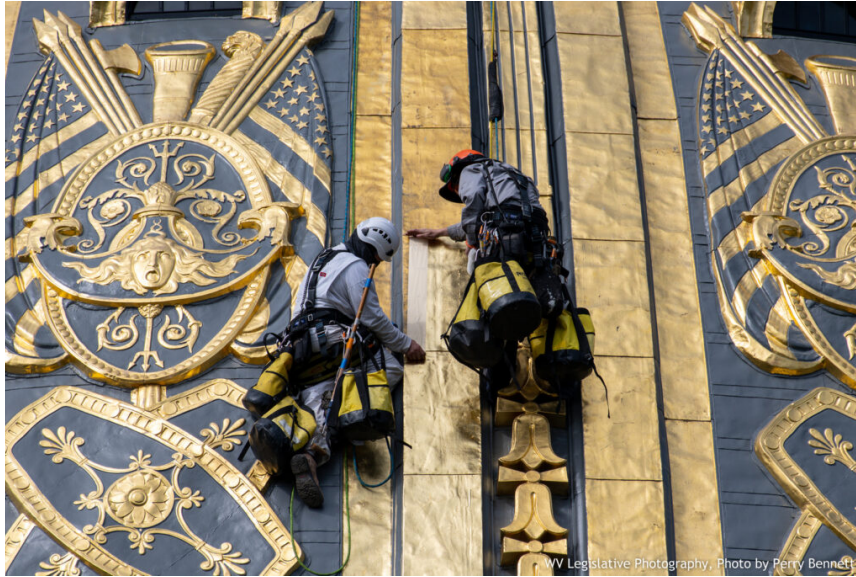
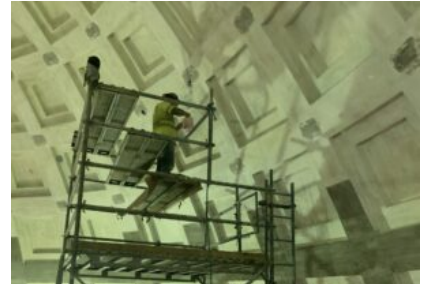
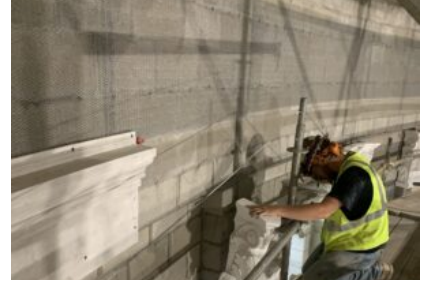
The exterior dome required patching at locations where the existing gilding was damaged throughout the dome cladding and seams as well as at the guardrail at the observation deck. We repaired holes of the inner dome by filling the voids with wads of coconut fibers and plaster and then skimming the voids to bring the plaster flush with the adjacent surfaces. Additionally, our restoration team installed plaster ornament below the windows, demolished damaged pieces to allow for new installation, replicated the Colonnade Level Interior Oak Leaf Capitals, and reinstalled cast plaster.
