Historic White House Gates

ALEXANDRIA, VA

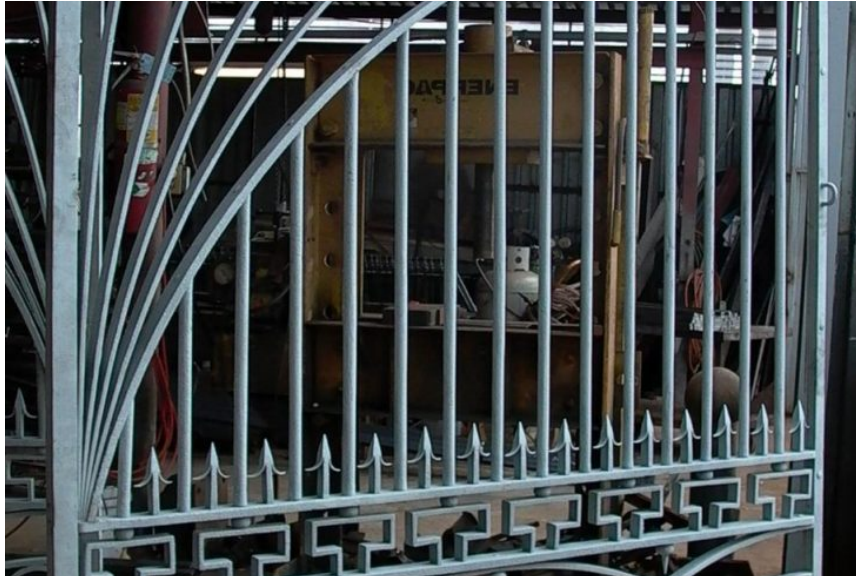
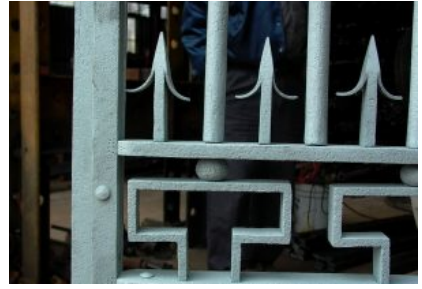
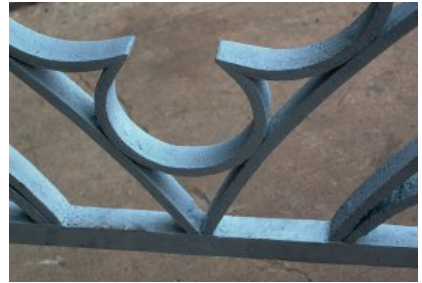
The ironwork gates had deteriorated over their long service life both during storage and while at the White House. Elements were bent and deformed from rust jacking and some pickets were missing. Hardware was missing or had been replaced with inappropriate modern units. Fourteen layers of paint covered the finely formed ironwork and the existing color did not match the original deep forest green.

In 2005, our conservators were contracted to study the gates, perform paint analysis to determine the original color, recommend, design, and oversee the conservation treatment to restore them to their original appearance. Micrographic stratigraphy was performed to identify the original finish paint color and drawings were made of the gates to direct the work and document the addition of new elements. Specifications for treatment and recoating were prepared and the work was performed by others but overseen by us. The gates were then exhibited before being permanently installed at the River Farm site.
