Embedded Objects Find a New Home in the New Museum

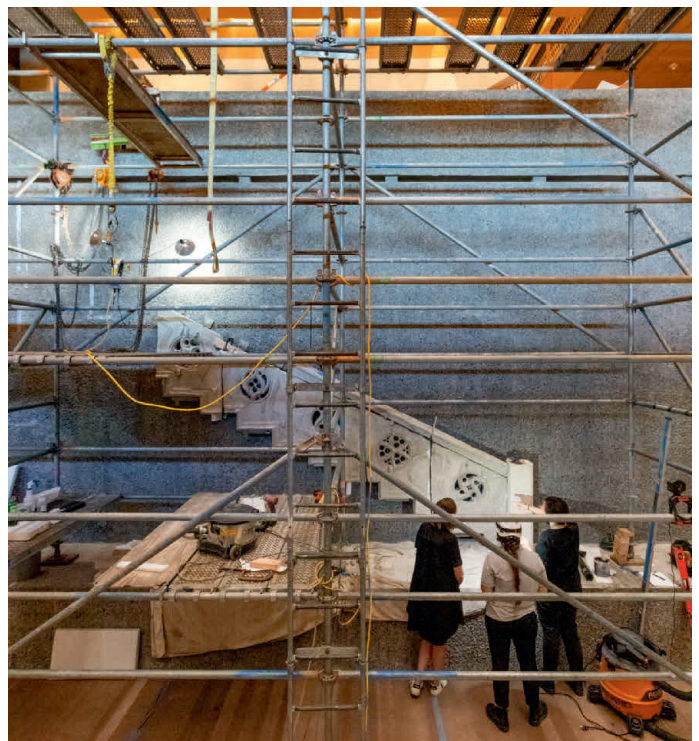
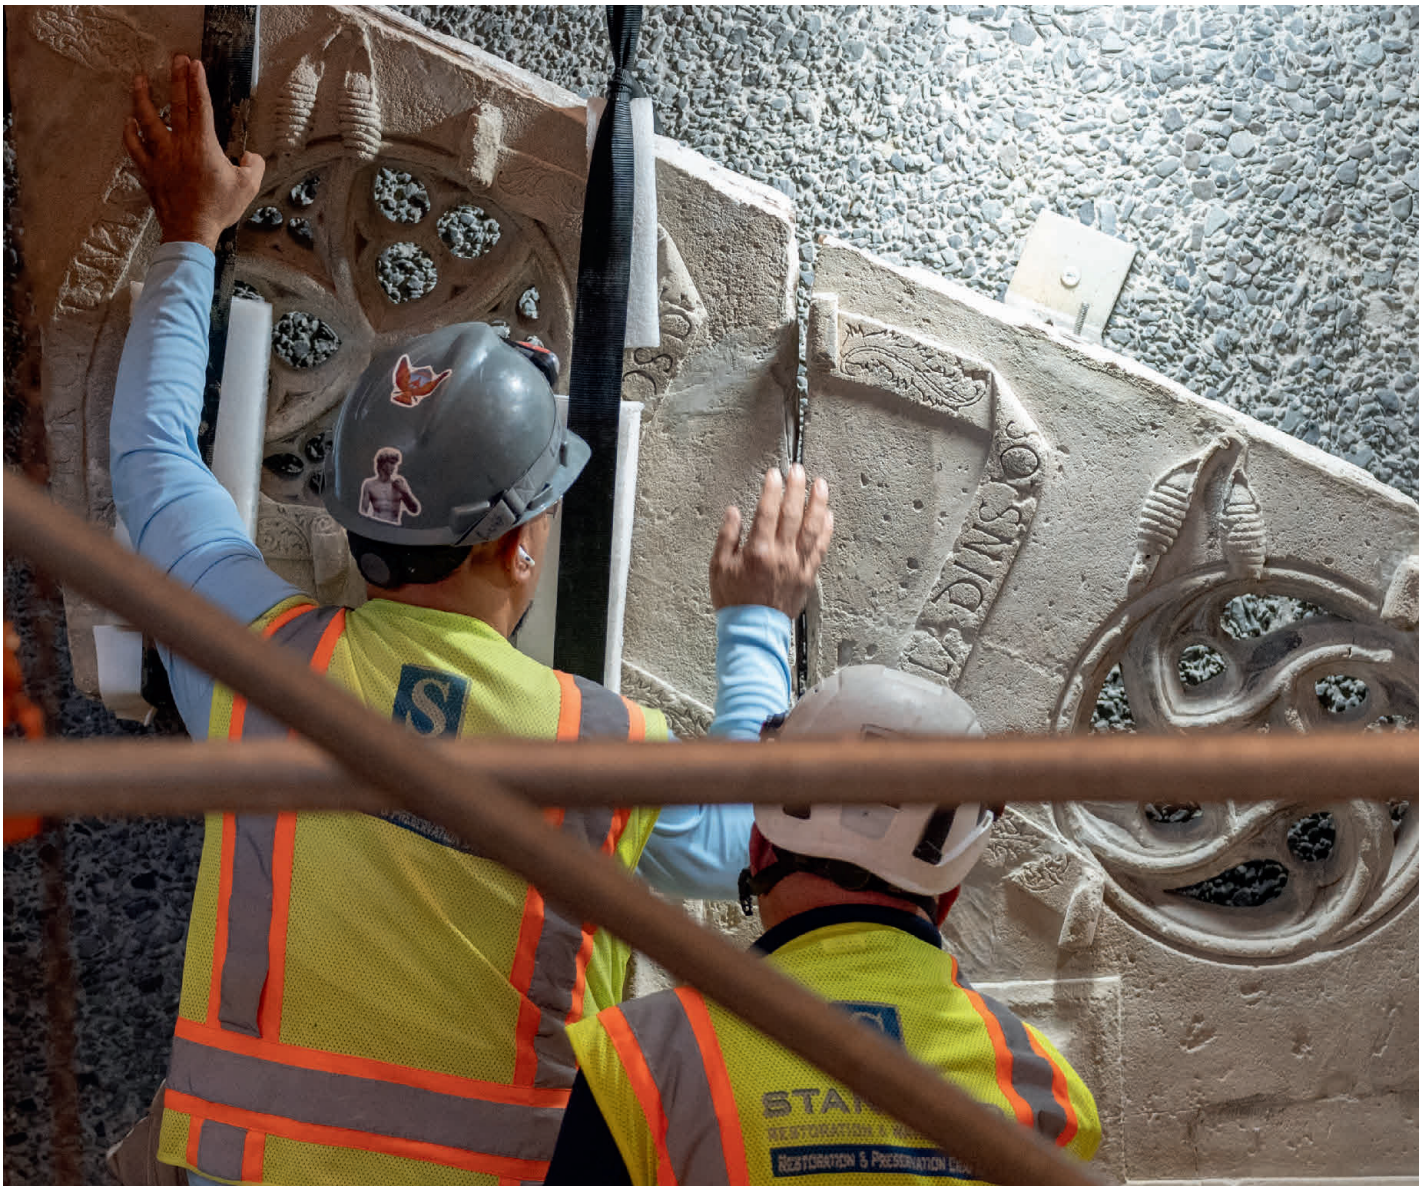
OPPOSITE PAGE: Alexandra Letvin, Duane Wilder, Class of 1951, Associate Curator of European Art; Silvia Callegari, conservator at EverGreene Architectural Arts; and Elena Torok, associate objects conservator, discuss the installation of the Museum’s stone works from Palma de Mallorca, Spain: Balustrades and columns probably from the Can Ayamans (Ayamans House), 1549; Stairway probably from the Carrer de l’Aigua (Water Street), 15th or 16th century. Princeton University Art Museum. Gift of Baroness Cassel van Doorn. Photo: Joseph Hu | ABOVE: Installation team members fit together two large stone pieces of the stairway. Photo: Jeffrey Evans

Study Room. Once deinstalled—and after meticulous cleaning by the EverGreene team at their studio in District Heights, Maryland—the stairs were fully rebuilt over nine months to “better understand the spacing and updated engineering” necessary to install the piece in its eventual new home, according to Caldwell. As the piece was studied during its removal and conservation, including by Alexandra Letvin, the Duane Wilder, Class of 1951, Associate Curator of European Art, and then prepared for its reinstallation, special attention was paid to aligning curatorial goals, design, conservation, and engineering, allowing the team to “reconfigure the stairs to a more historically accurate reinterpretation.” Jacobs noted that he looks forward to seeing the installation of this piece the most among the works being embedded throughout the new

To reconstruct the stairway on-site, more than sixty heavy stone pieces of varying shapes and sizes were painstakingly moved into the building in travel cases through the new Museum’s large pivot door. On coordinating such logistics, Hughes said: “I want to acknowledge the people who maybe aren’t always seen—not just the Museum’s registrars, but also the preparators and conservators, our contractors, people in the facilities department, and the security staff. We can’t do any of this work without them. It takes everybody and all their professionalism to do these big jobs.”

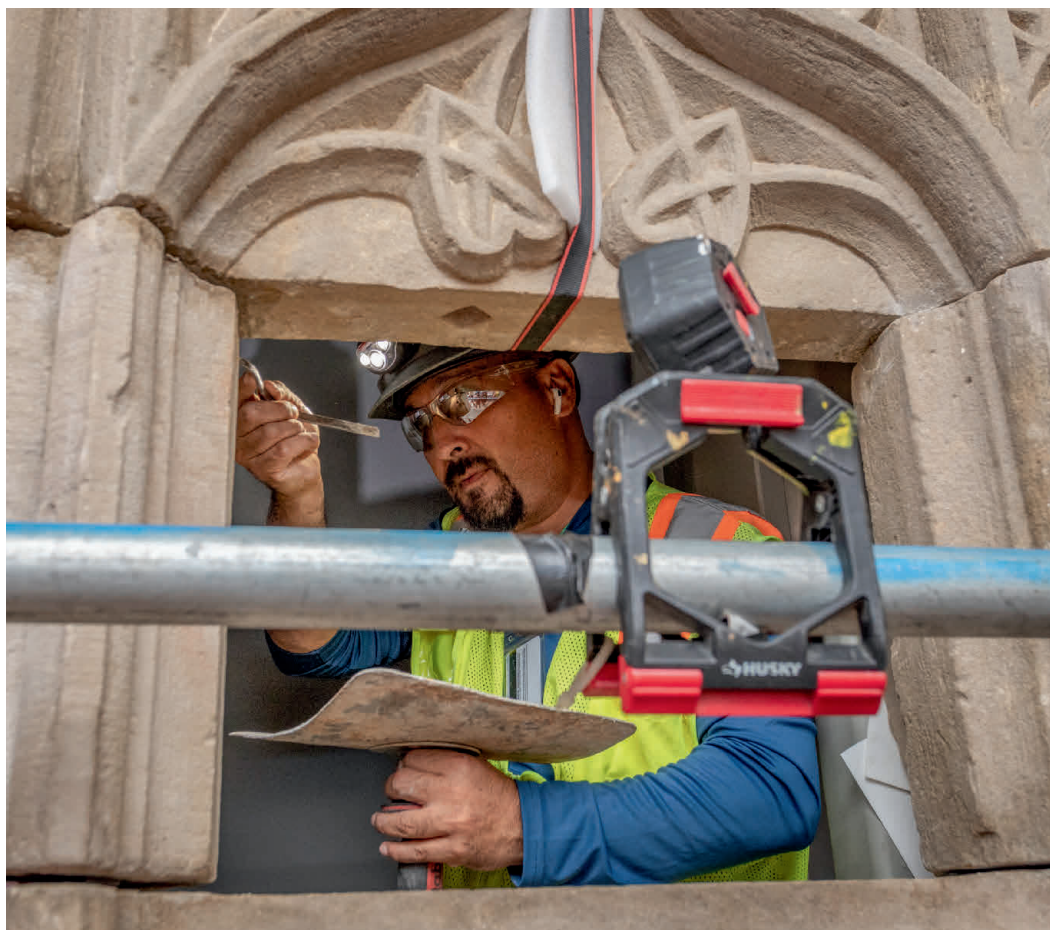
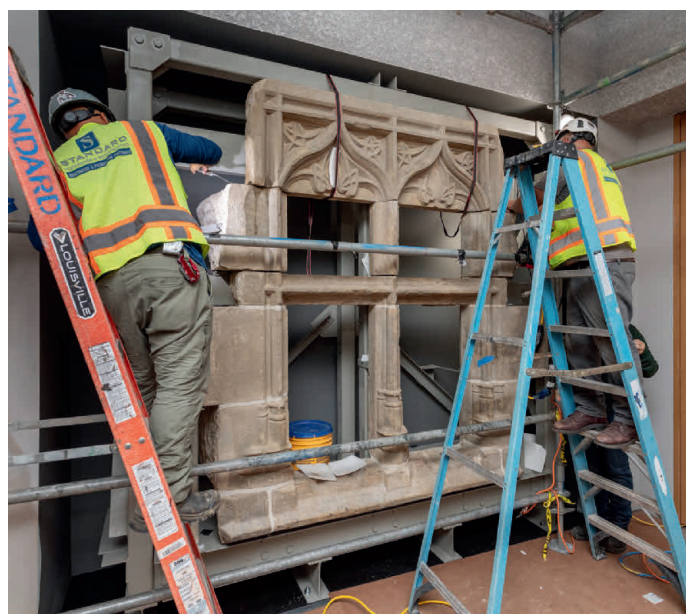
ABOVE AND RIGHT: Installation of the window from the Vaucluse, France, 15th century. Stone, 223.5 × 228 × 68.5 cm. Princeton University Art Museum. Gift of Baroness Cassel van Doorn. Photos: Joseph Hu

The Museum's fifteenth-century stone window from the Vaucluse region of France, formerly housed in a connecting space between galleries of the old Museum, has found a new home in the reception area that will greet users to the Museum's future object study rooms. An updated design approach results in visible industrial framing that enables the window to be examined more fully from both architectural and historical perspectives.

The large steel frame holding the window provides opportunities to gain valuable insights into the materiality of the stone and its numerous mason's marks, and viewers will be able to understand better how the piece once fit into its original architectural context.

Caldwell explained that in its new installation "the window is completely independent from the surrounding walls; the steel for this piece was custom designed." Additionally, the conservators at EverGreene, masonry contractors, riggers, and engineers worked to create an installation plan that prioritized minimal interventions into the original elements of the monumental window: "No new attachment points were made; we utilized all of the existing old pinholes or the existing shapes of the stones," Caldwell noted.

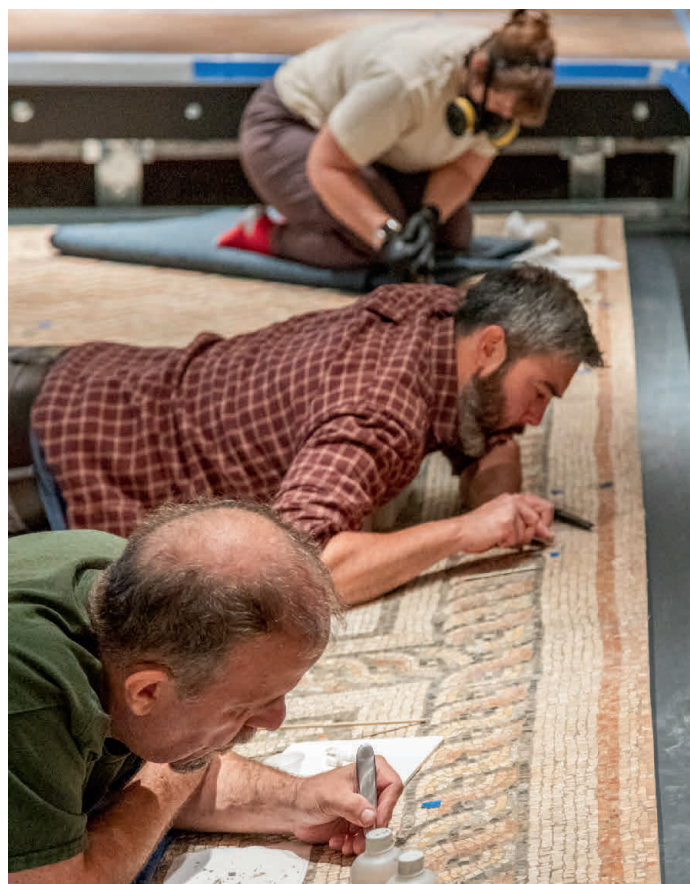
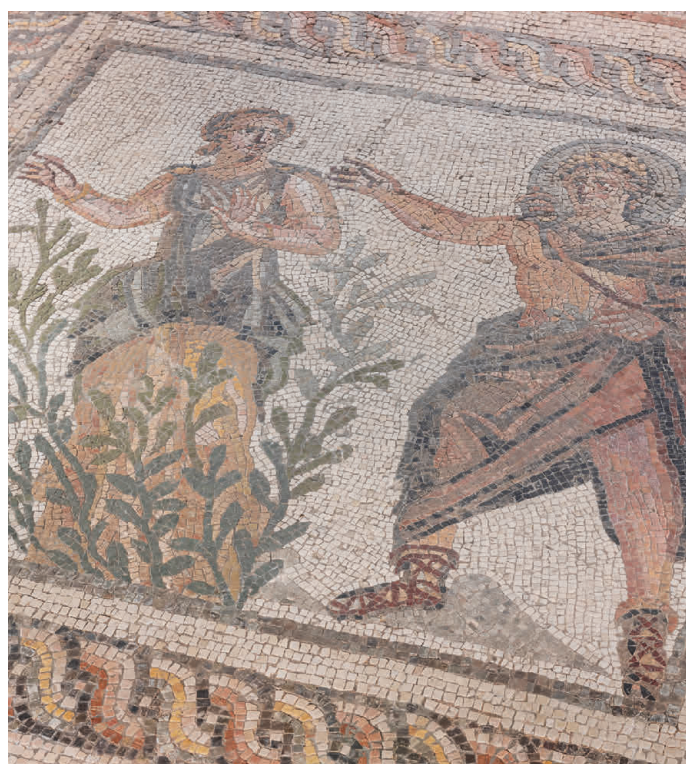
OPPOSITE PAGE, TOP: Conservators from Adam Jenkins Conservation Services finalize details of the installation of the mosaic pavement depicting Apollo and Daphne | BOTTOM: Roman Imperial Period (ca. 30 BCE–476 CE), Asia Minor (Turkey), Mosaic pavement depicting Apollo trying to assault Daphne (detail), late 3rd century CE. Stone, 190 × 592 cm. Princeton University Art Museum. Gift of the Committee for the Excavation of Antioch to Princeton University. Photos: Joseph Hu

Among the most highly anticipated moments in the process of returning these monumental works to the new Museum have been the placement of several of the Museum's ancient Roman mosaic pavements, excavated in the early twentieth century near Antioch, in present-day Turkey, as part of a multinational partage excavation project. To accommodate these works in the new building and allow visitors to understand them in their original settings, cavities were built into the building's floors in different locations to house three of the mosaic fragments. Once the mosaics are placed into the cavities, and the works are cleaned one last time, protective glass flooring is installed above to allow for viewing. Visitors will be able to stand above these ancient pavements and have

The required conservation treatments performed by AJCS for these mosaics were overseen by Torok, Devolder, and Associate Curator of Ancient Mediterranean Art Carolyn Laferrière. The treatment of the *Drinking Contest of Herakles and Dionysos* was particularly complex. In this case, a new aluminum honeycomb backing was adhered to the mosaic to provide much-needed stabilization for the ancient tesserae, the tiny square elements that constitute the mosaic. The pavement fragment comprises several sections, each weighing hundreds of pounds, that had to be separated from one another and later reassembled like puzzle pieces. Specially designed low-profile casters were mounted to the underside of each section's aluminum backing so that once lowered into the floor cavity, the segments could be wheeled together and tied in place. Of the complicated engineering and conservation decisions made while handling the *Drinking Contest*, Jenkins said, "For me, that problem-solving was the most rewarding part of this. We presented innovations not already extant in the field and found good solutions at every stage that were reviewed by engineers and then implemented successfully."
